**AIRCRAFT
ACCIDENT
REPORT
Trans World Airlines Flight 800
Part III
Door Story**

**Report on the accident to
Trans World Airlines Flight 800
Boeing 747-131, N93119
Near East Moriches, New York
July 17, 1996
by John Barry Smith,
Independent Aircraft Accident Investigator**

Part III: Door Story

Forward Cargo Door Areas Compared for United Airlines Flight 811, Pan Am Flight 103, Air India Flight 182, and Trans World Airlines Flight 800.

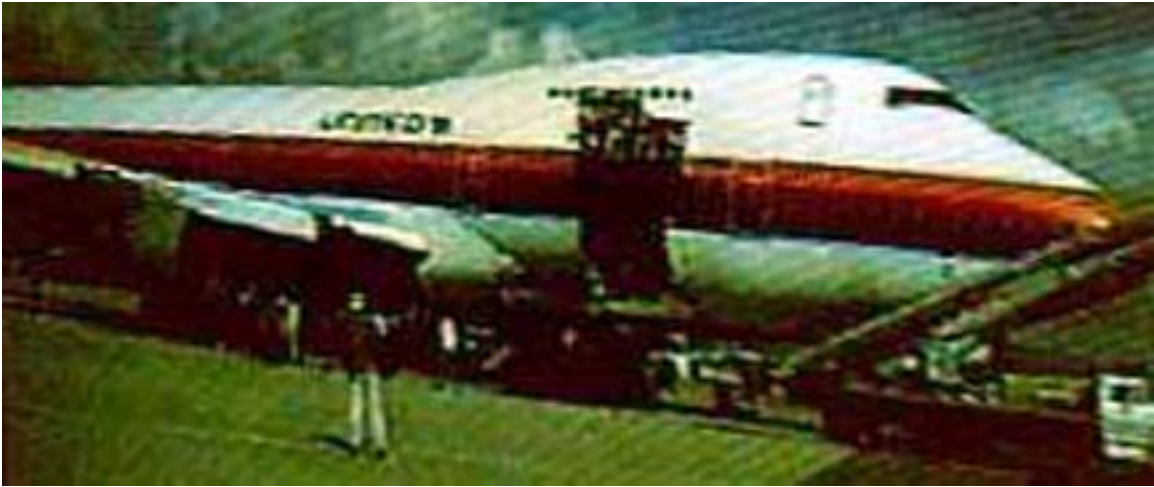
Photo of hole in United Airlines Flight 811 made by inadvertent opening of forward cargo door in flight. Note rectangular shape.

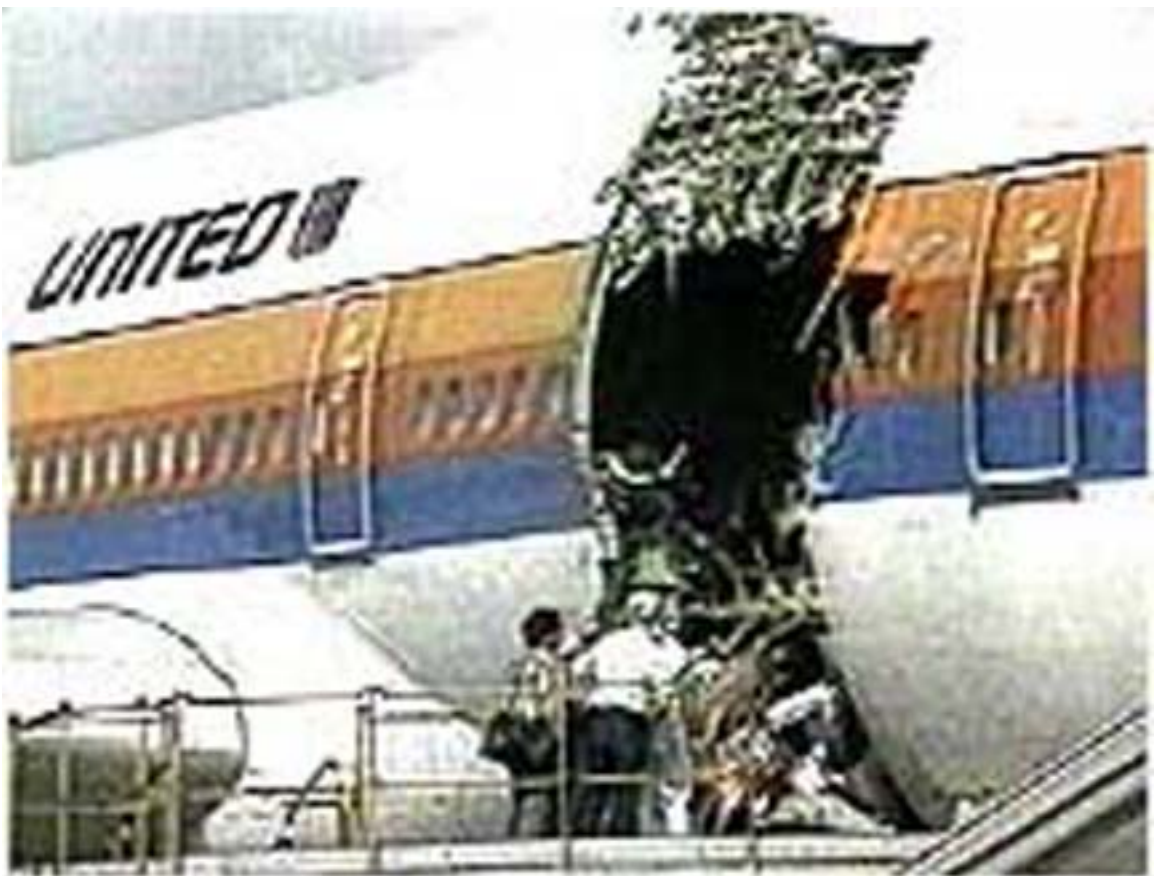
Photo of hole in United Airlines Flight 811 made by inadvertent opening of forward cargo door in flight.

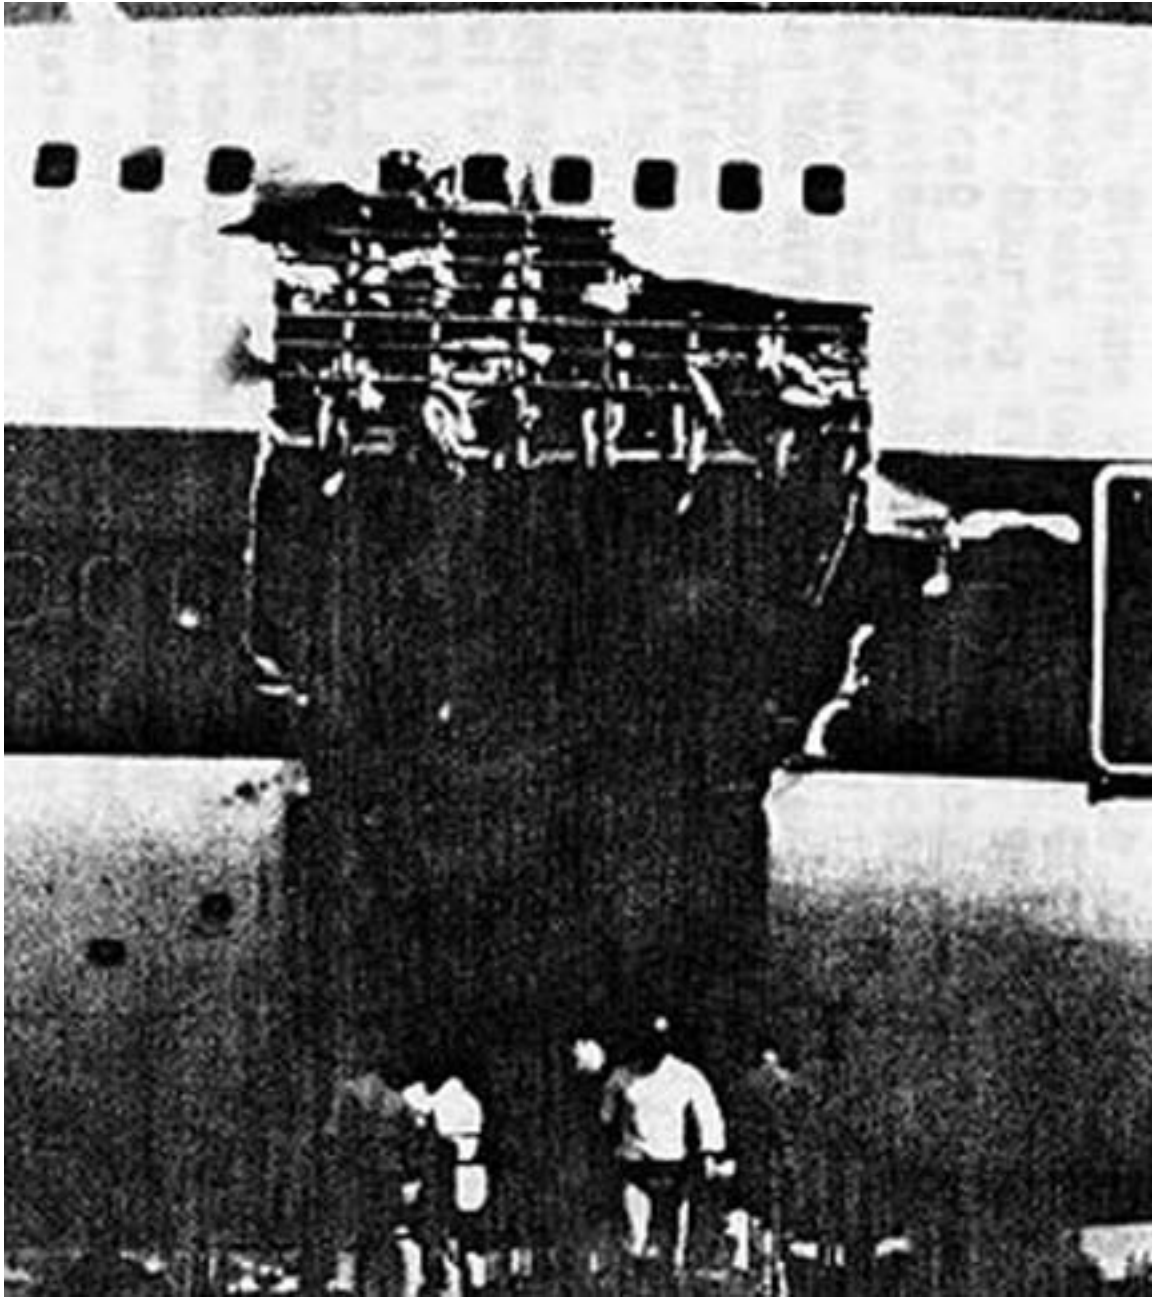
Photo from NTSB AAR 92/02 of hole in United Airlines Flight 811 made by inadvertent opening of forward cargo door in flight.

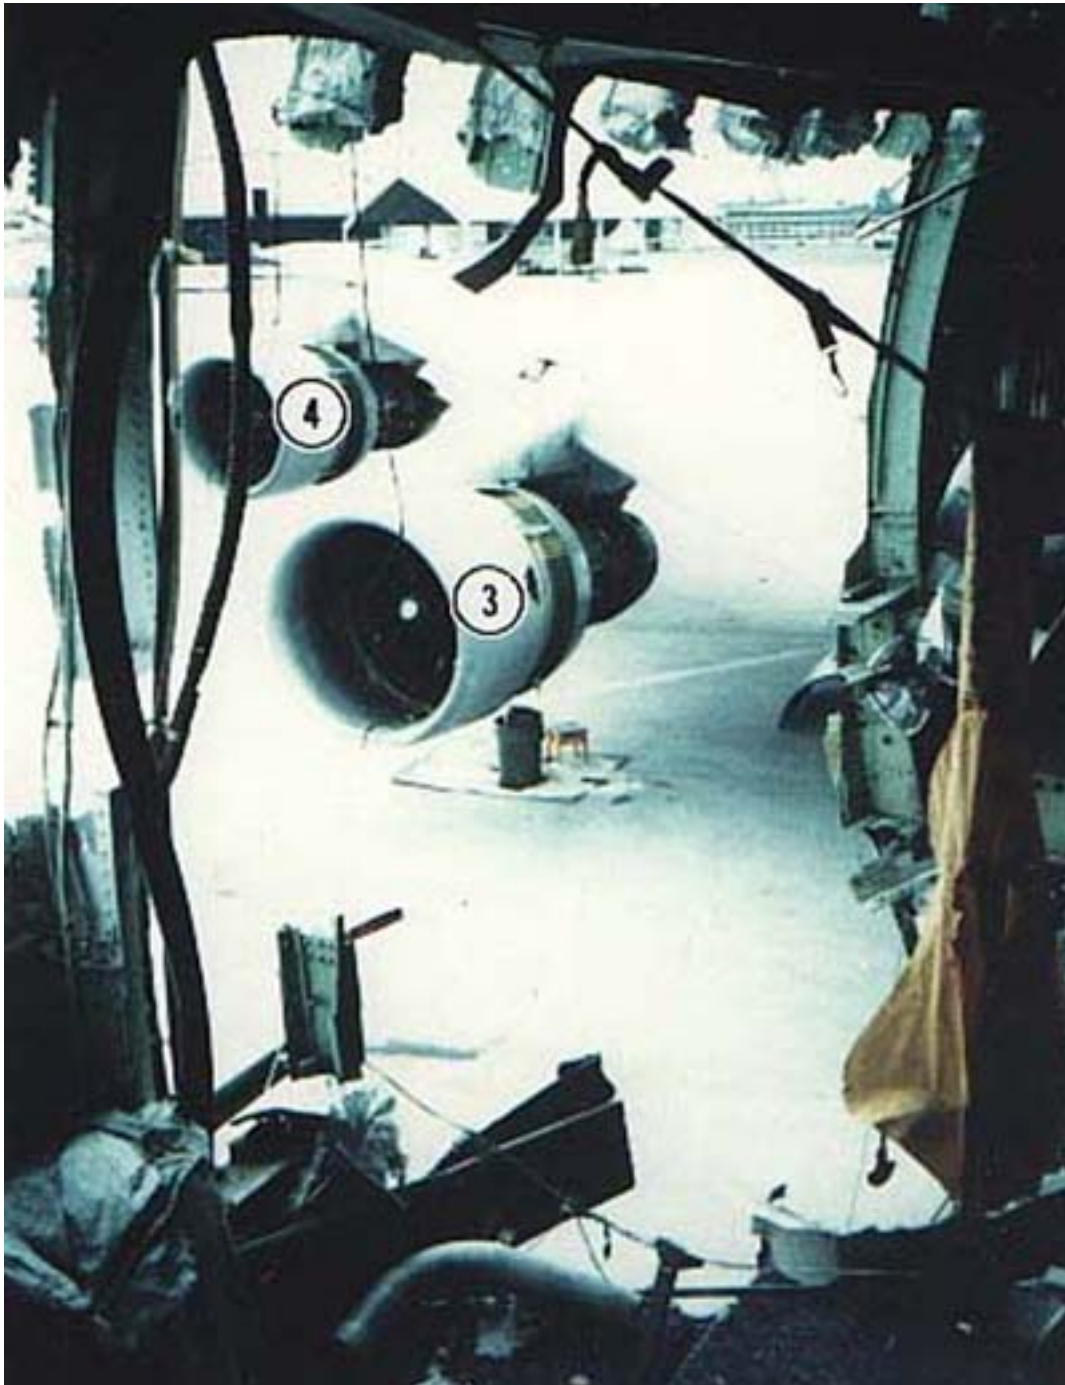
Photo from inside United Airlines Flight 811 showing the hole caused by inadvertent opening of forward cargo door in flight revealing engine numbers three and four which received the ejected foreign objects which caused the fire and internal engine damage.

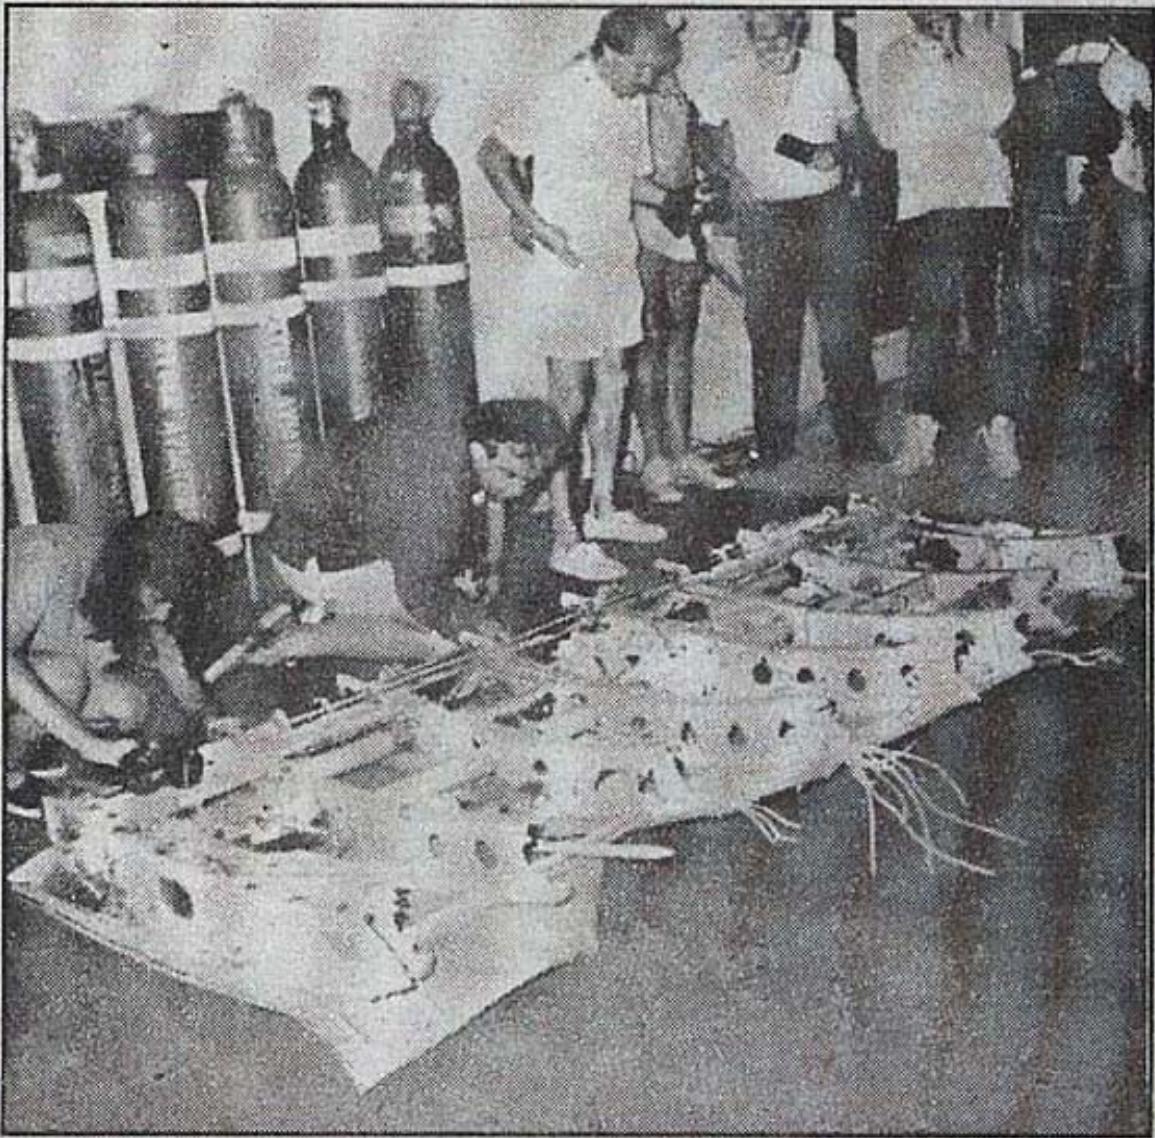
The bottom half of the cargo door from United Flight 811 is examined on board a Navy contract support ship after it was retrieved from a depth of nearly three miles. The crew of the mini-sub Sea Cliff hopes to recover the top half this weekend. See story on Page A3.

Photo of newspaper article and photograph showing the lower half of retrieved forward cargo door, loose wiring, the longitudinal split at midspan latches, and the peeled away skin from the aft midspan latch.

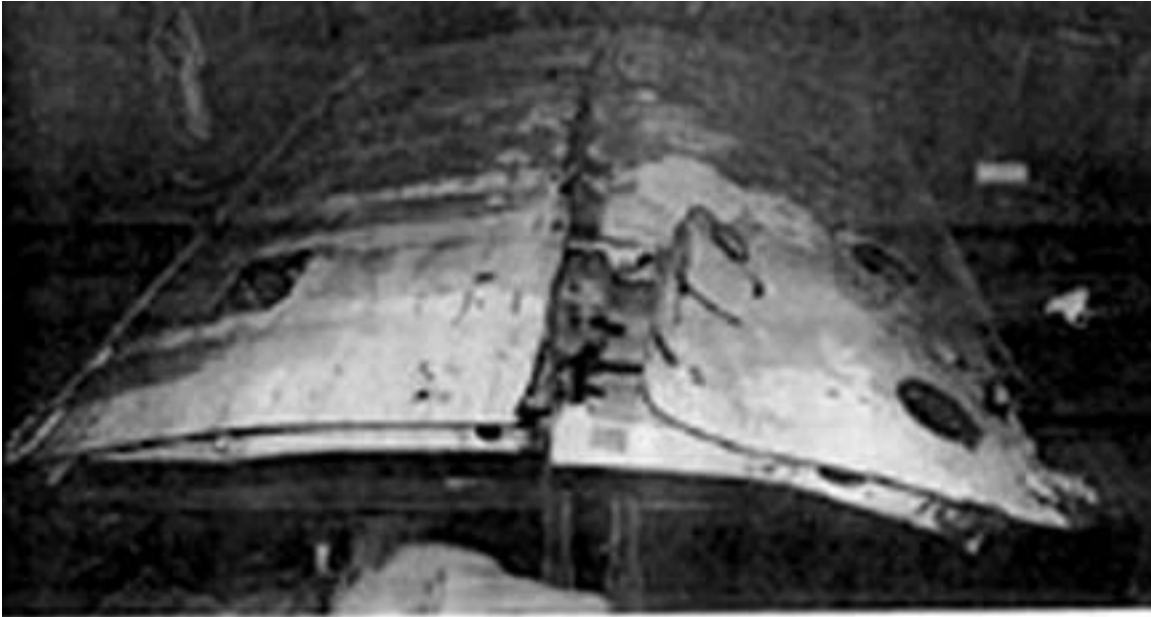
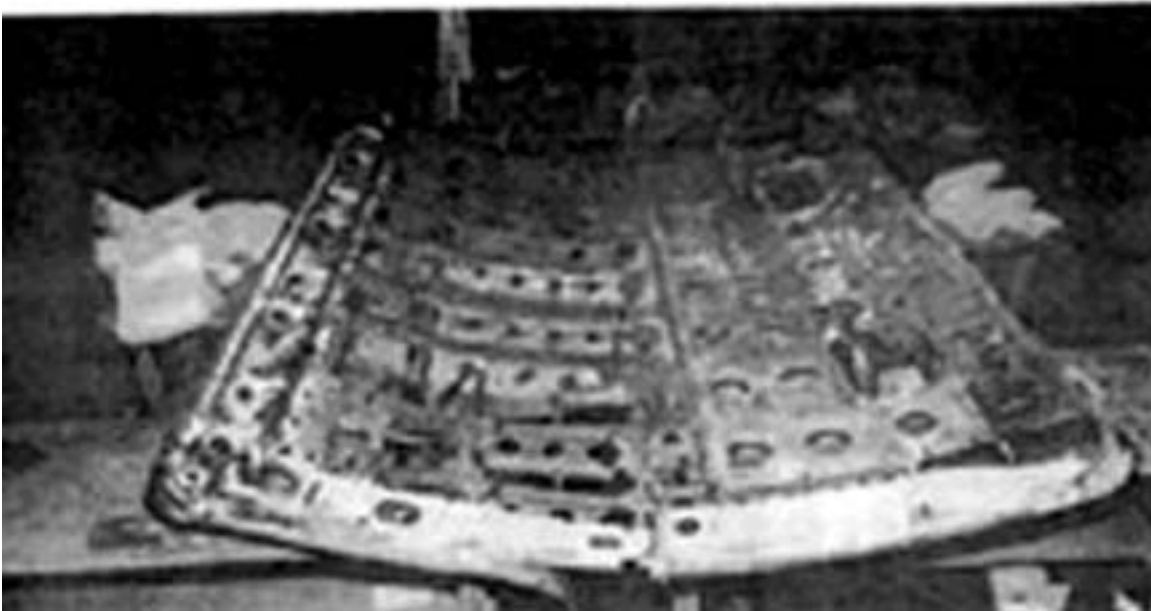
Photo from NTSB AAR 92/02 for United Airlines Flight 811 showing both halves of the retrieved door, the longitudinal split at midspan latches, and the peeled away skin from the aft midspan latch.

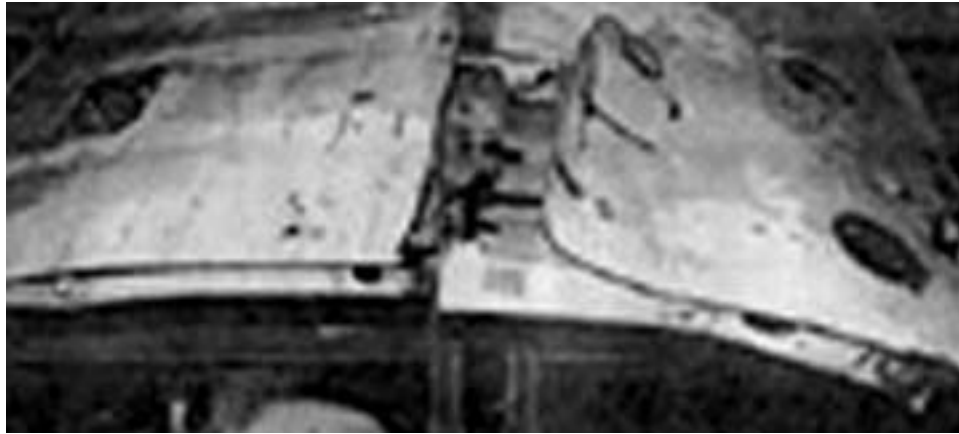
Closeup photo from NTSB AAR 92/02 for United Airlines Flight 811 showing bottom half of the retrieved door, the longitudinal split at midspan latches, and the peeled away skin from the aft midspan latch.

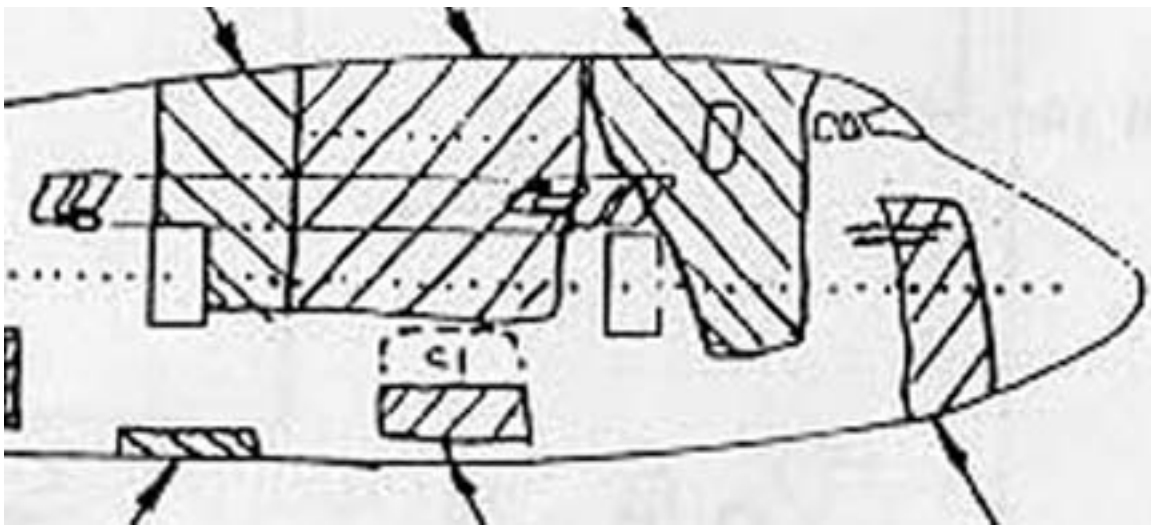
Reconstruction drawing from the Kirpal Report and the CASB report on Air India Flight 182 showing the longitudinal split of the forward cargo door and the vertical tearing of the skin above the door.

"2.11.4.6 All cargo doors were found intact and attached to the fuselage structure except for the forward cargo door which had some fuselage and cargo floor attached. This door, located on the forward right side of the aircraft, was broken horizontally about one-quarter of the distance above the lower frame. The damage to the door and the fuselage skin near the door appeared to have been caused by an outward force. The fractured surface of the cargo door appeared to have been badly frayed."

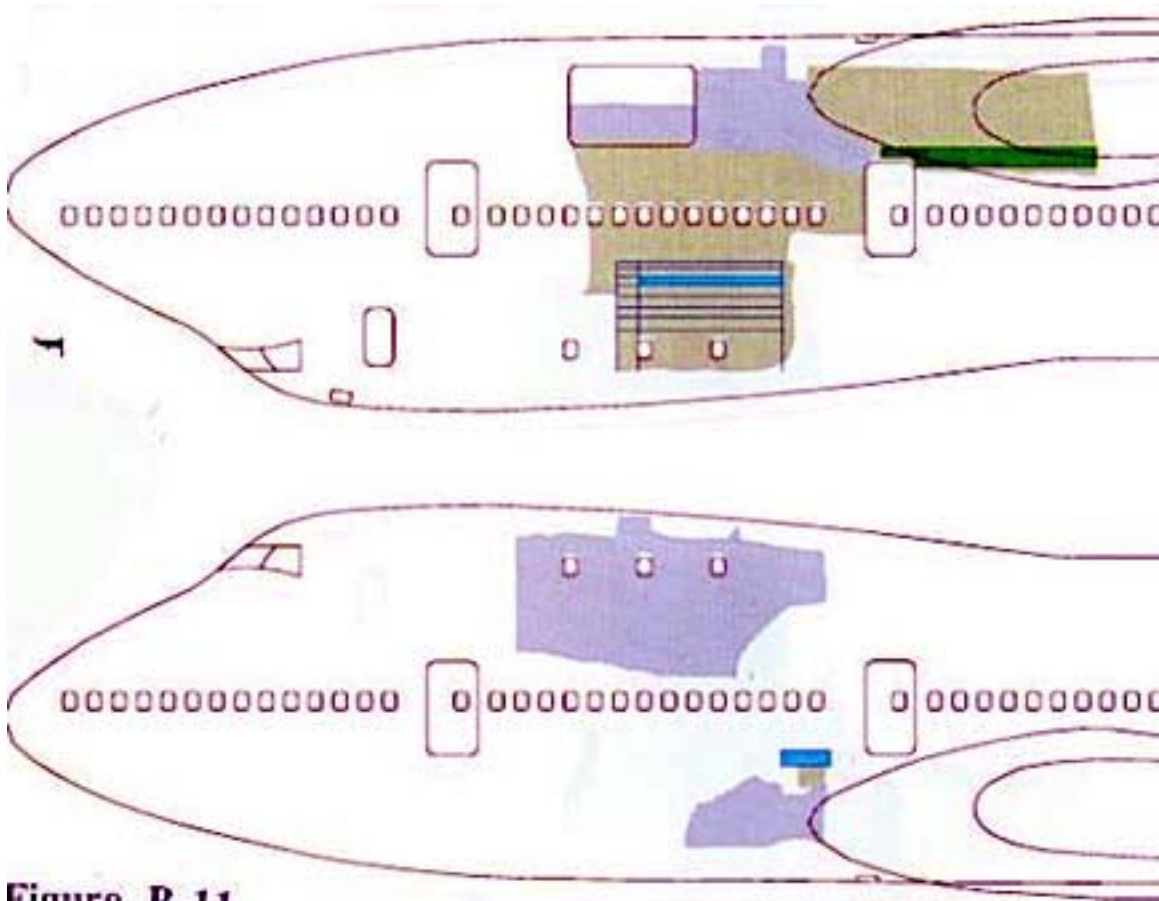
Figure B-11

Figure B11 from AAIB 2/90 for Pan Am Flight 103 showing initial event time fuselage destruction with small 'bomb' hole rectangle on port side and huge rectangular destruction around forward cargo door on starboard side.

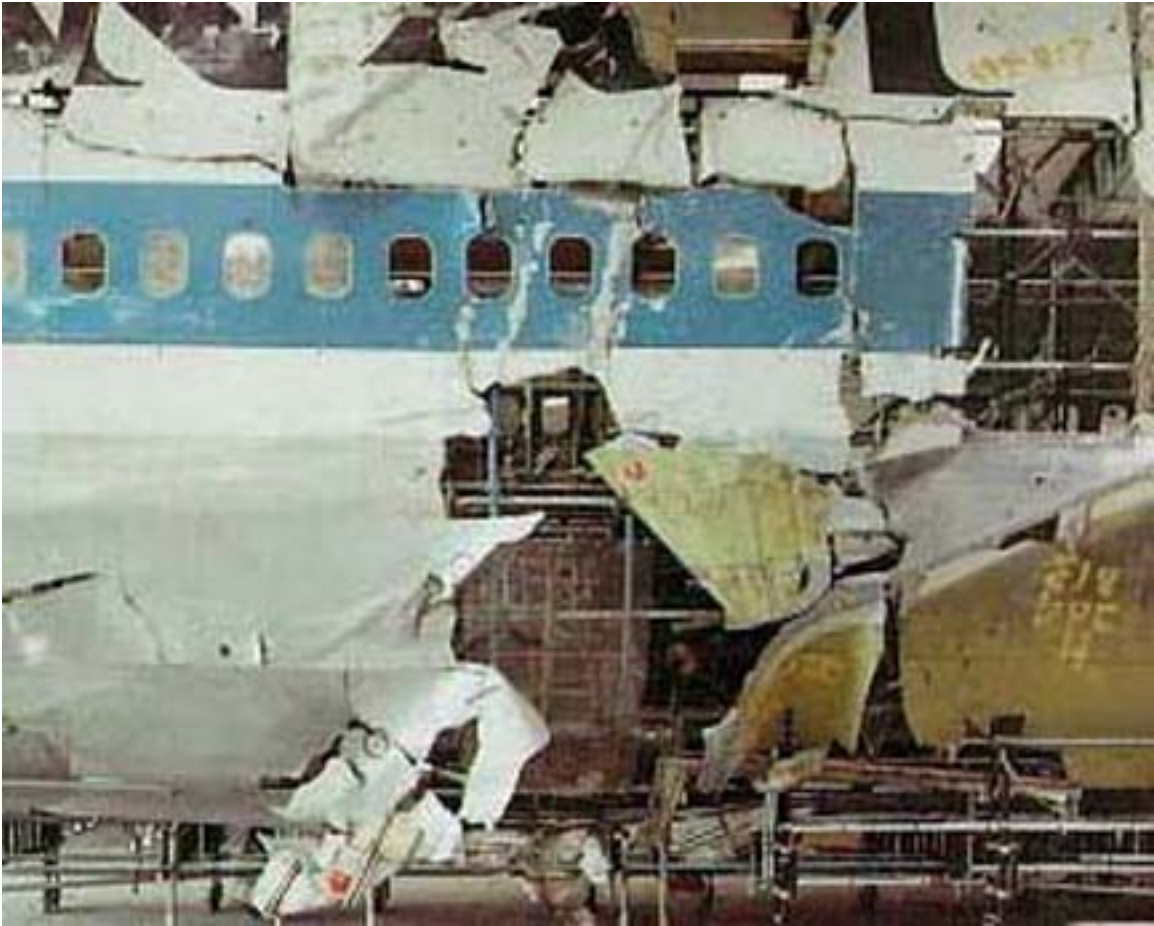
Port side of Pan Am Flight 103 forward of the wing showing the small 'bomb' hole and relatively smooth and intact fuselage skin around it.

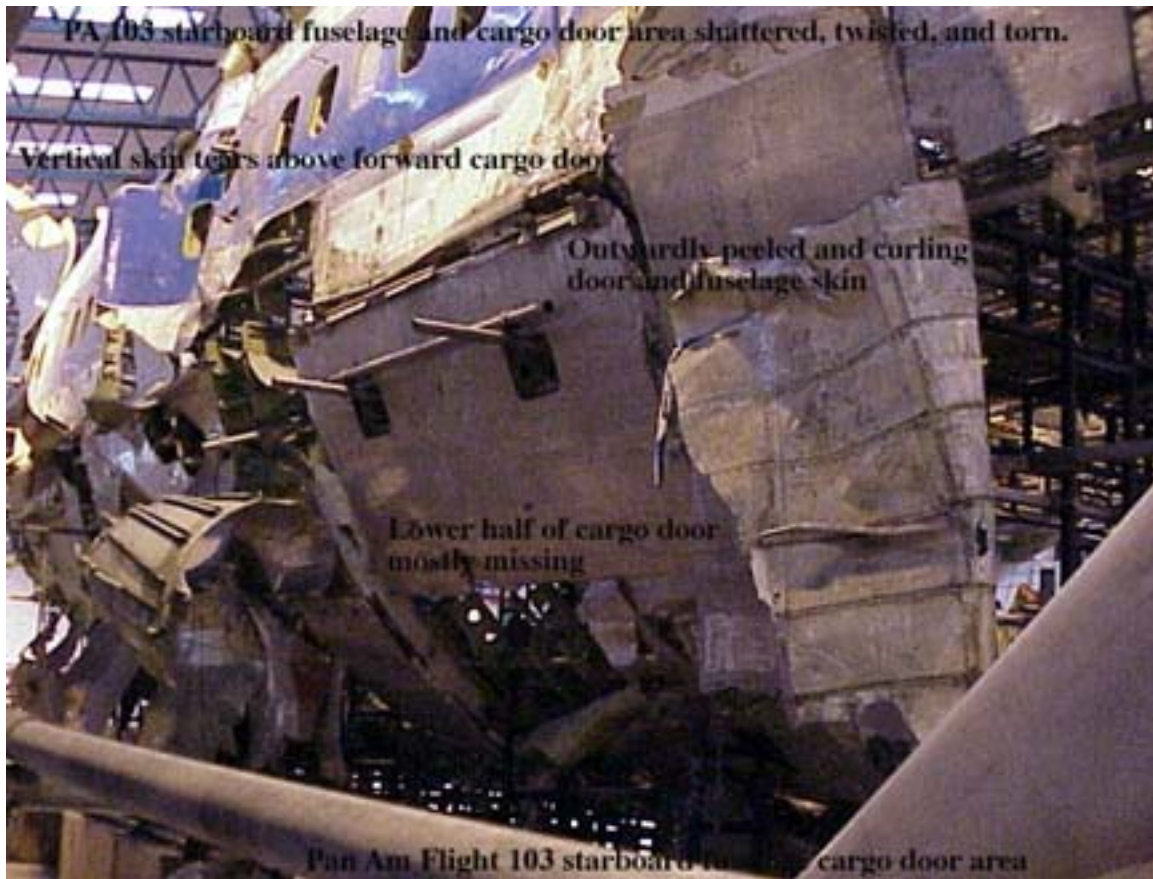
Photograph from AAIB showing Pan Am Flight 103 forward cargo door area revealing the vertical torn skin above door, peeled back and down skin from the aft midspan latch, generally shattered area, and mostly missing lower half of door which includes the manual locking handle and the eight bottom latches.

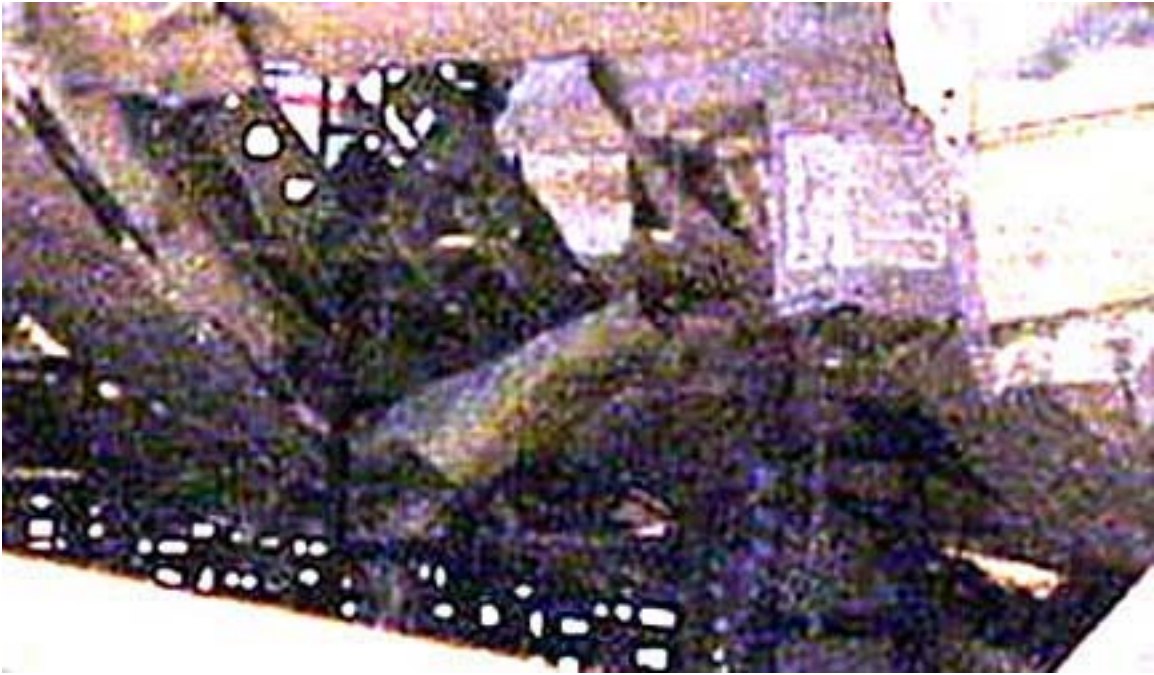
Closeup of the peeled back skin from the aft midspan latch of the forward cargo door of Pan Am Flight 103.

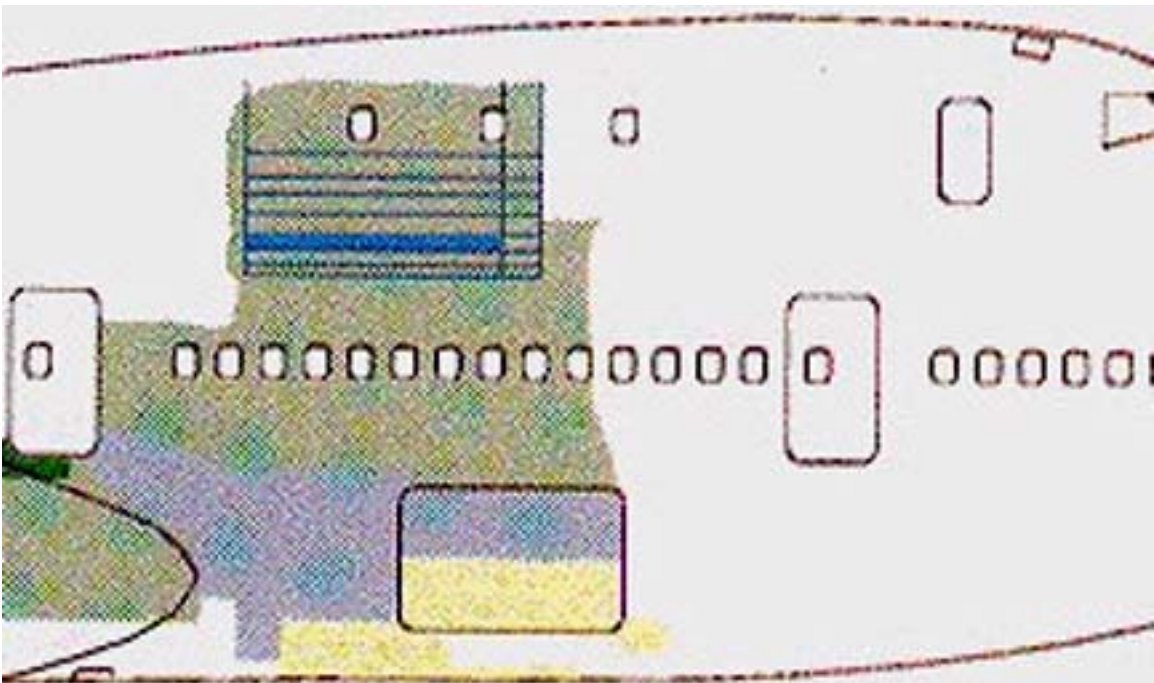
Reconstruction drawing from the AAIB 2/90 report on Pan Am Flight 103 showing the large area of torn off skin around the forward cargo door, the longitudinal split of the door, and the vertical tearing of the skin above the door.

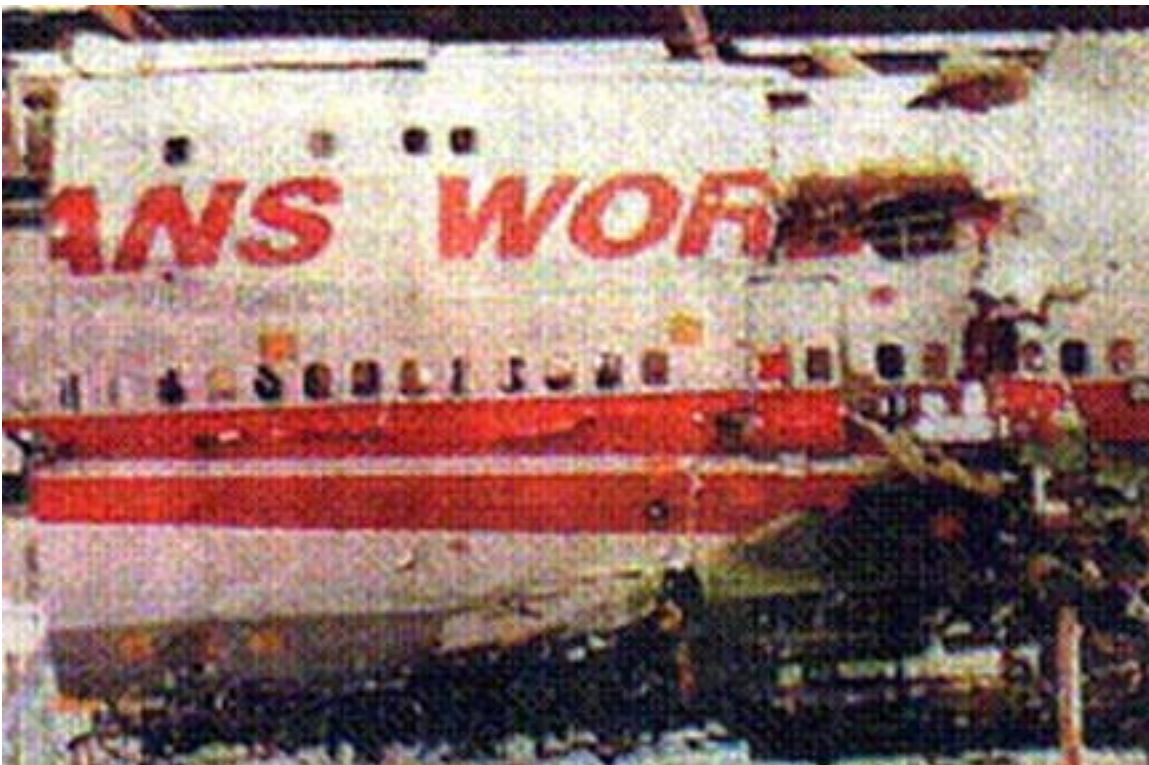
Photograph of the port side of Trans World Airlines Flight 800 showing the relatively undamaged skin forward of the wing, nose to left.

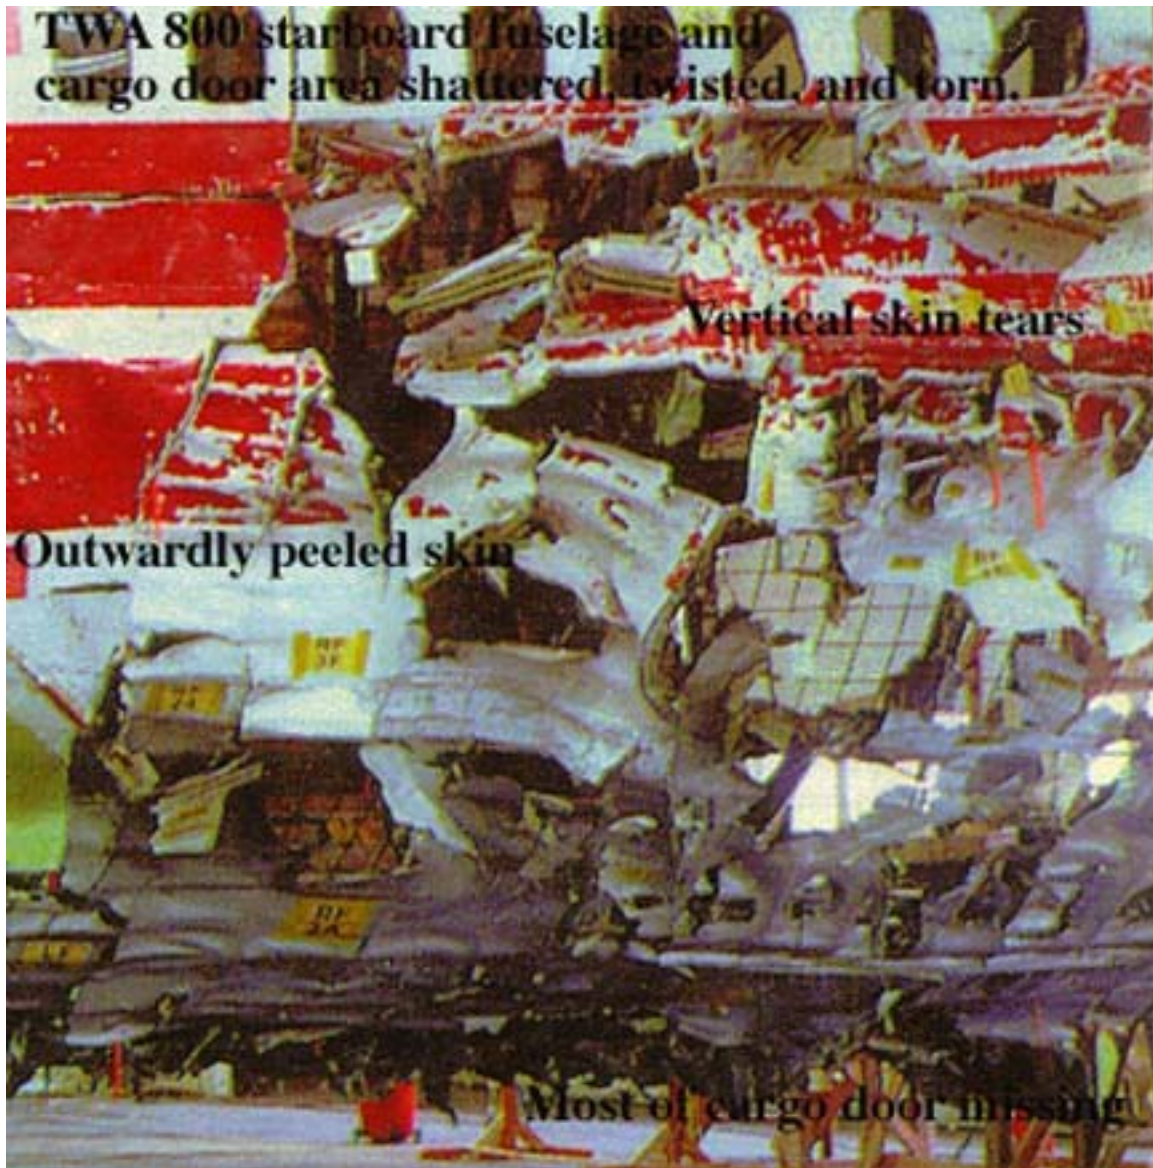
Shattered starboard side around forward cargo door of Trans World Airlines Flight 800 revealing outwardly and petaled shaped skin around aft midspan latch.

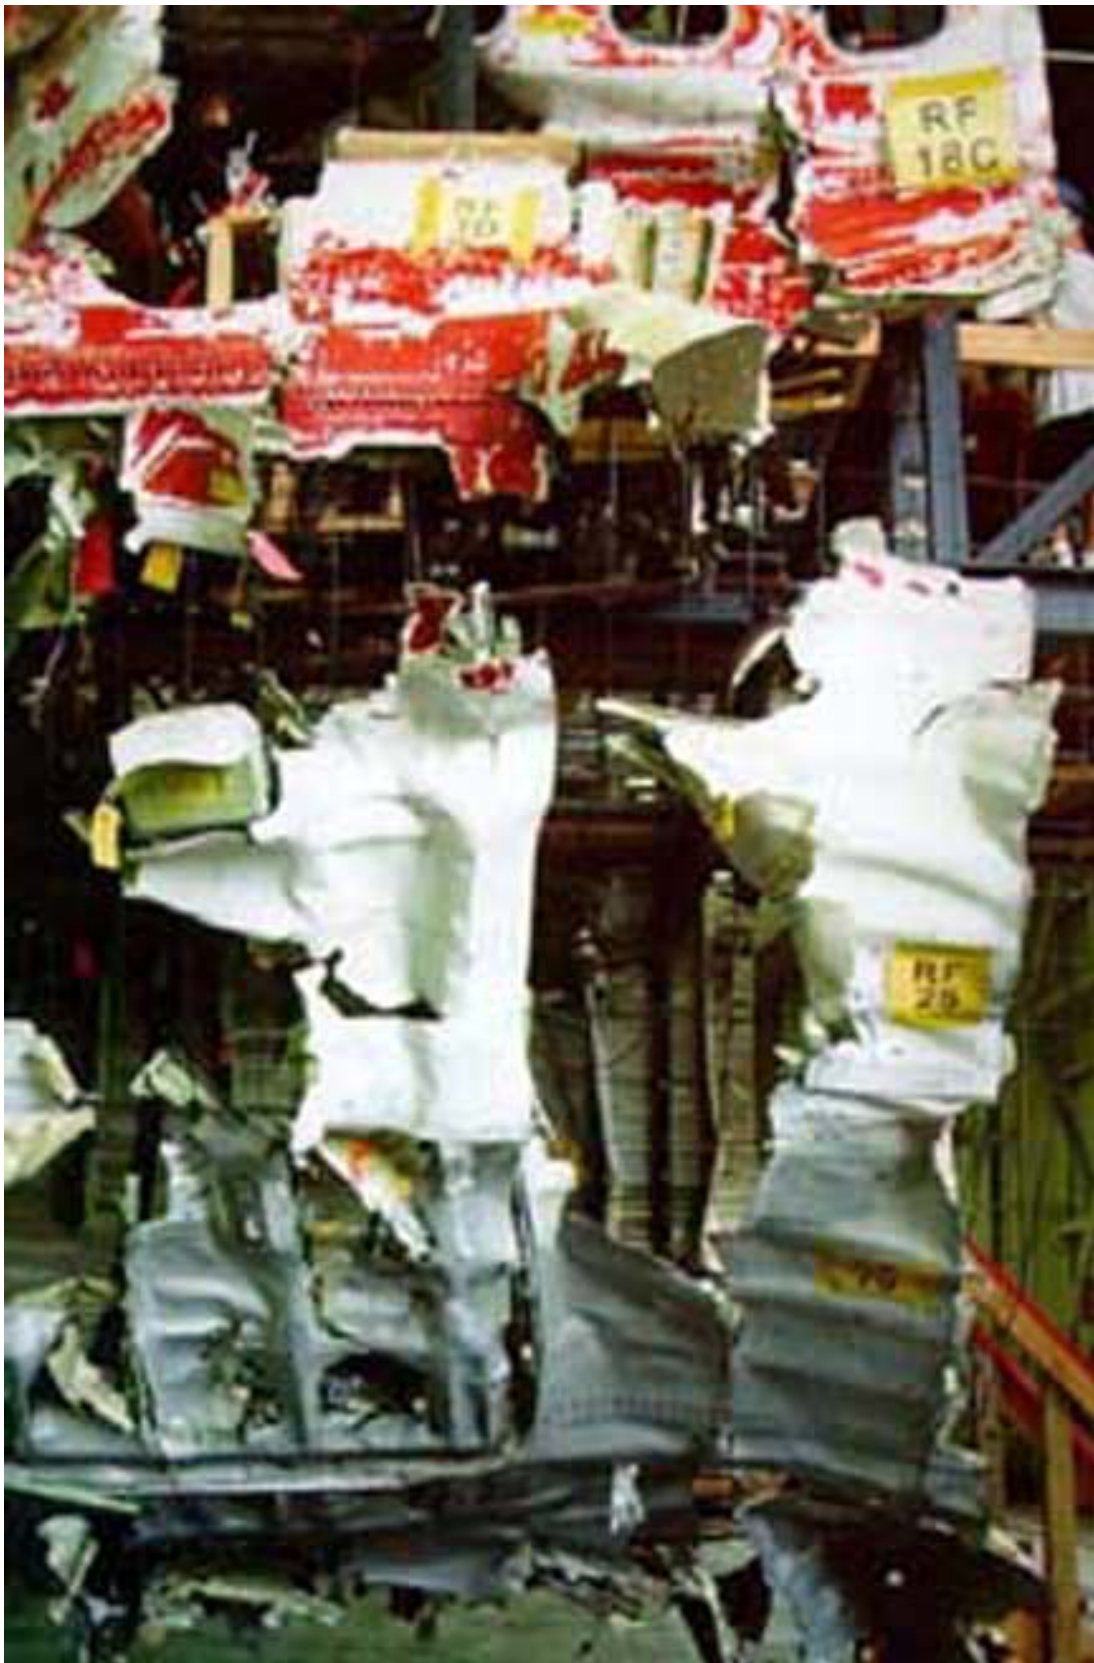
Photograph above showing outwardly and petaled shaped skin around forward midspan latch.

3. Docket Number SA-516, Exhibit No. 15C, Report Number 97-82, Section 41/42 Joint, Forward Cargo Door, "Examination of the lower lobe forward cargo door showed that all eight of the door latching cams remain attached (along with pieces of the door itself) to the pins along the lower door sill."

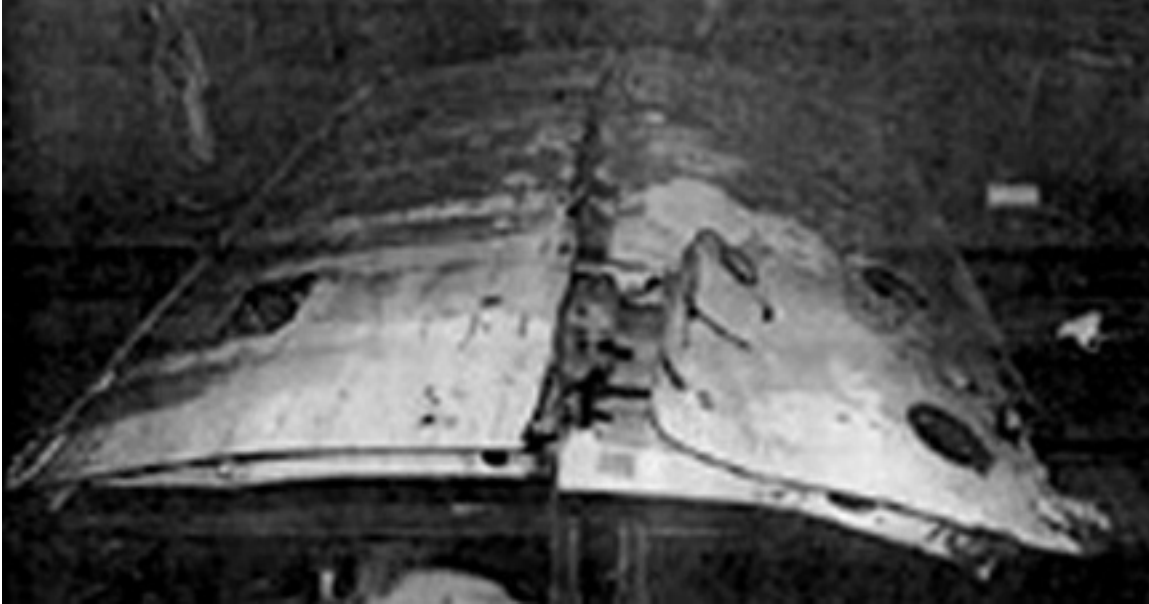
Photos from NTSB AAR 92/02 for United Airlines Flight 811 showing bottom half of the retrieved door, the longitudinal split at midspan latches, and the peeled away and down skin from the aft midspan latch.

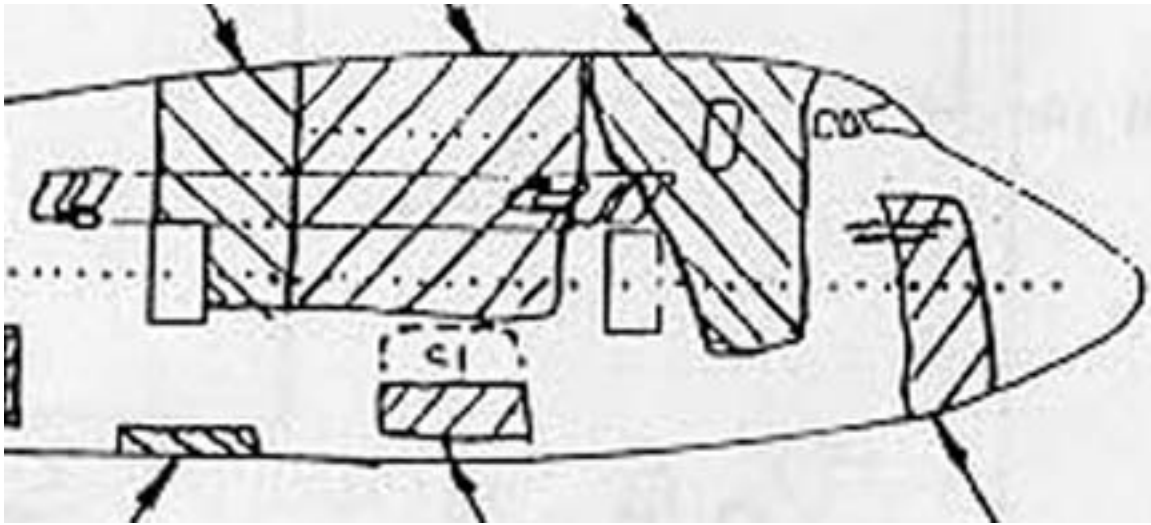
B. Air India Flight 182. From Kirpal and CASB AAR: 2.11.4.6 Section 42
All cargo doors were found intact and attached to the fuselage structure except for the forward cargo door which had some fuselage and cargo floor attached. This door, located on the forward right side of the aircraft, was broken horizontally about one-quarter of the distance above the lower frame. The damage to the door and the fuselage skin near the door appeared to have been caused by an outward force. The fractured surface of the cargo door appeared to have been badly frayed. Because the damage appeared to be different than that seen on other wreckage pieces, an attempt to recover the door was made by CCGS John Cabot. Shortly after the wreckage broke clear of the water, the area of the door to which the lift cable was attached broke free from the cargo door, and the wreckage settled back onto the sea bed. An attempt to relocate the door was unsuccessful.

Reconstruction drawing above from the Kirpal Report and the CASB report on Air India Flight 182 showing the longitudinal split of the forward cargo door and the vertical tearing of the skin above the door.

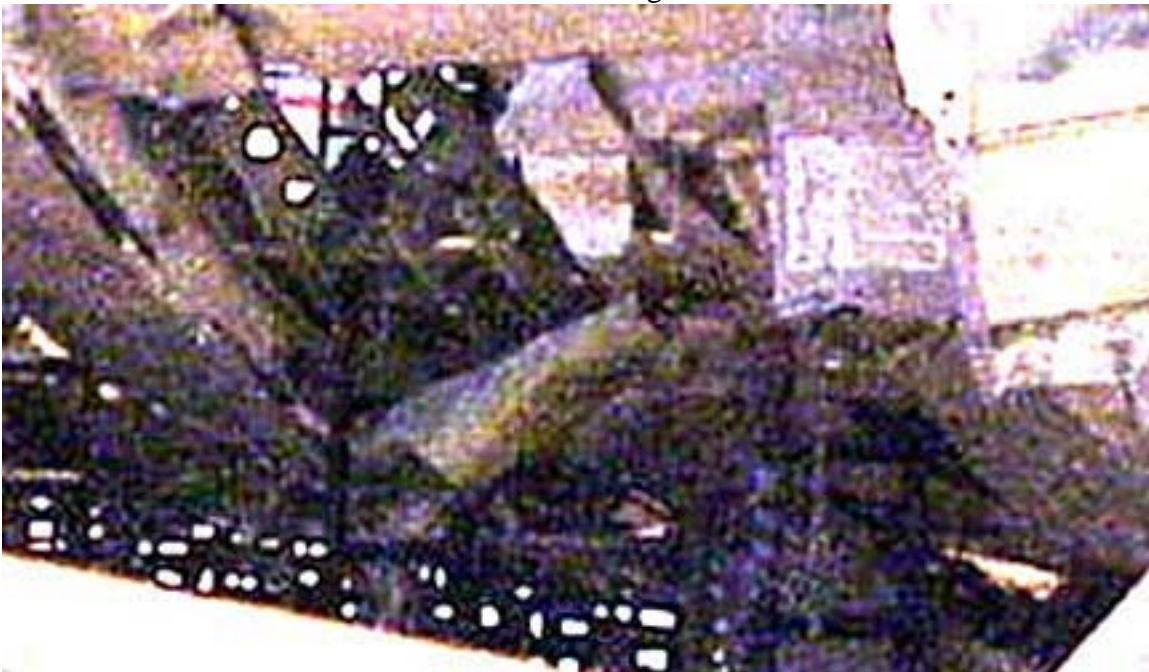
Closeup of the peeled back and down skin from the aft midspan latch of PA 103 forward cargo door.

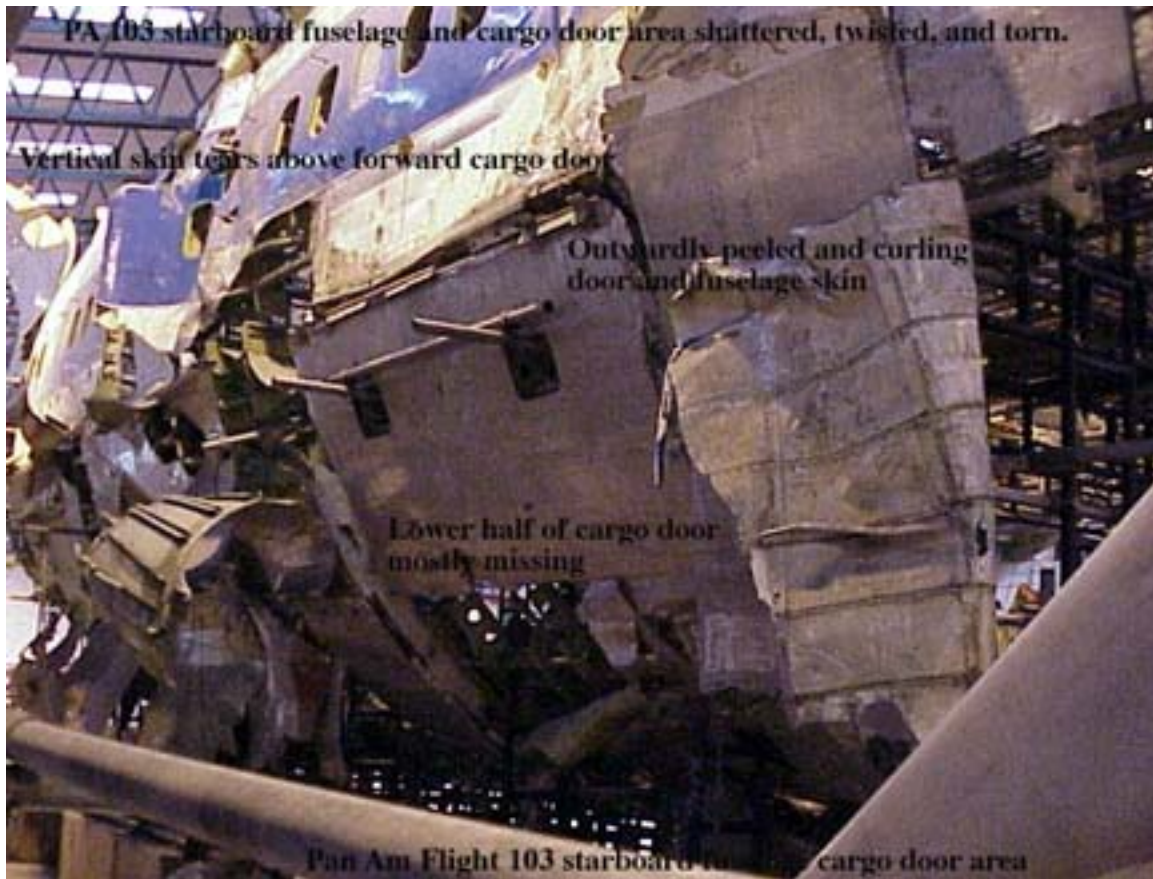
Photograph from AAIB showing Pan Am Flight 103 forward cargo door area revealing the vertical torn skin above door, peeled back and down skin from the aft midspan latch, generally shattered area, and mostly missing lower half of door which includes the manual locking handle and the eight bottom latches.

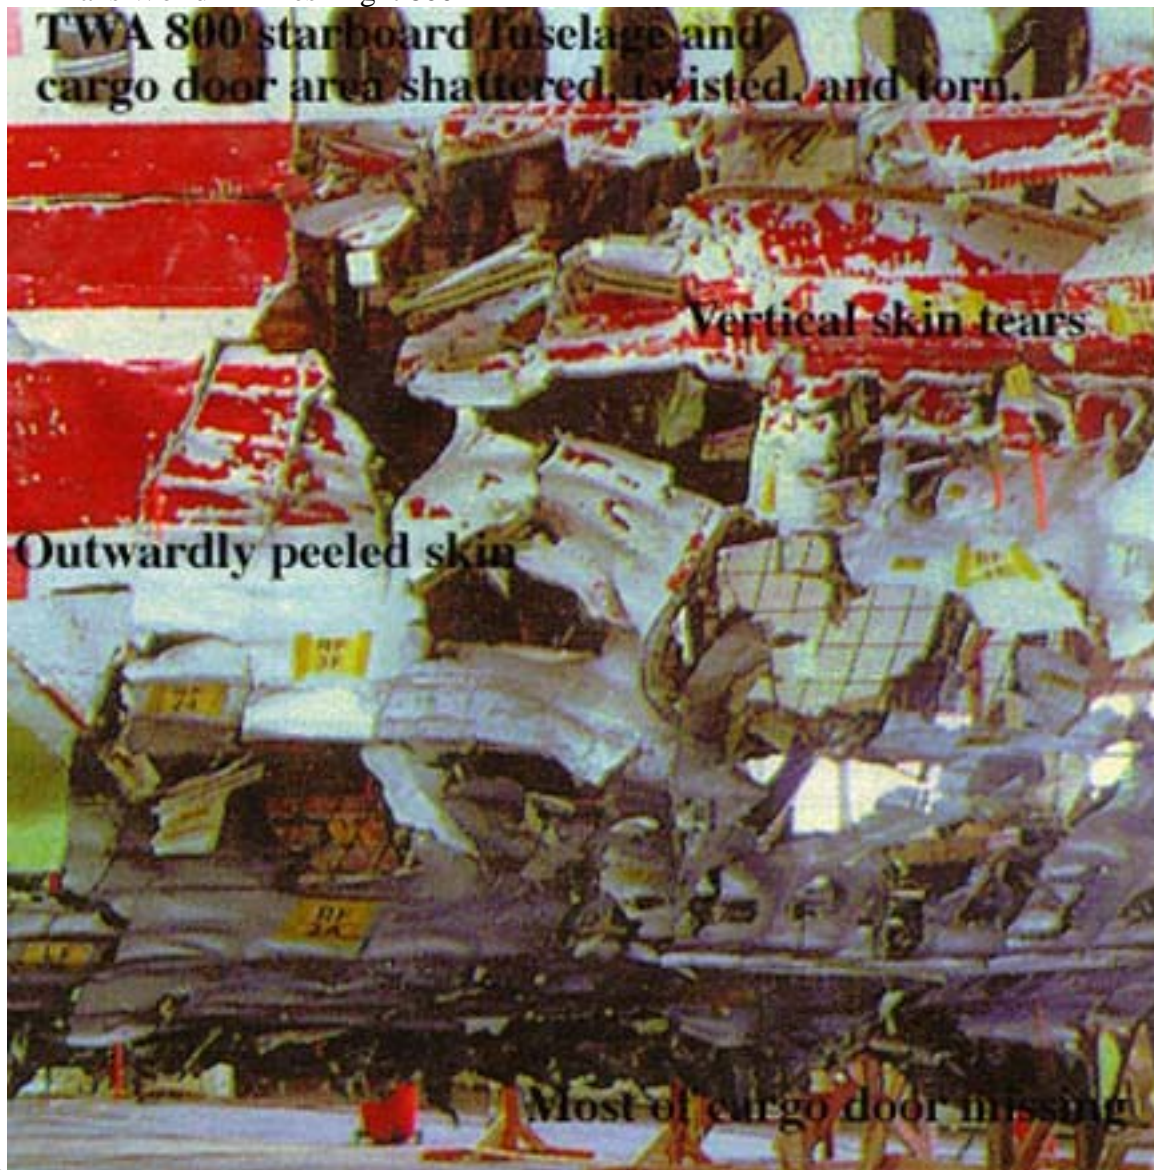
Shattered starboard side around forward cargo door of Trans World Airlines Flight 800 revealing outwardly and petaled shaped skin around aft midspan latch.
