**AIRCRAFT
ACCIDENT
REPORT
Trans World Airlines Flight 800
Part III
Door Story**

**Report on the accident to
Trans World Airlines Flight 800
Boeing 747-131, N93119
Near East Moriches, New York
July 17, 1996
by John Barry Smith,
Independent Aircraft Accident Investigator**

Part III: Door Story

Forward Cargo Door Areas Compared for United Airlines Flight 811, Pan Am Flight 103, Air India Flight 182, and Trans World Airlines Flight 800.

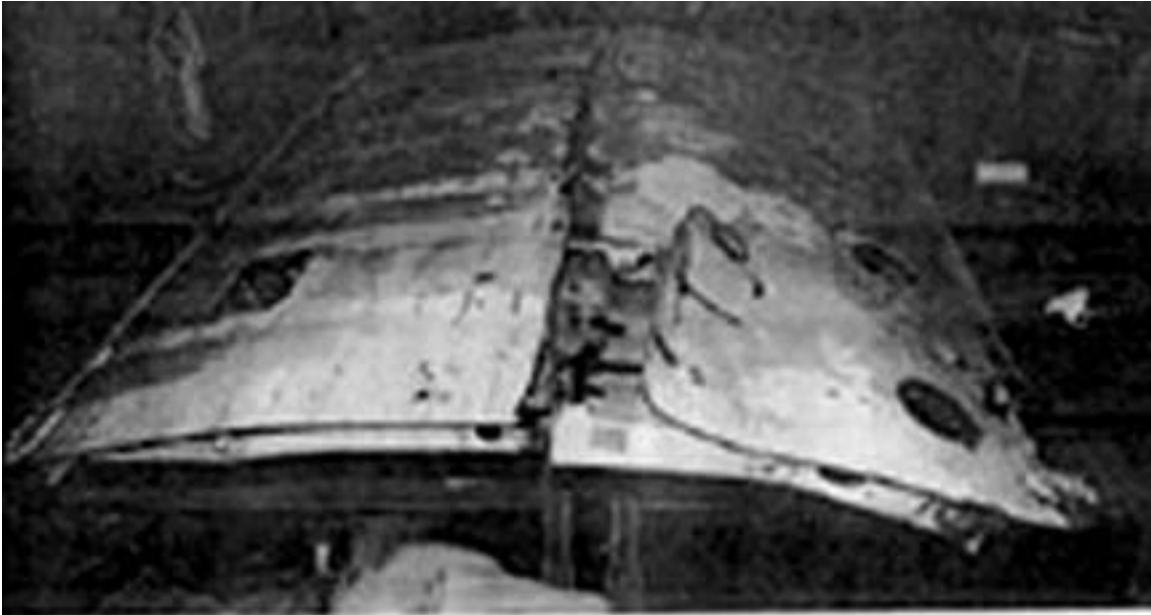
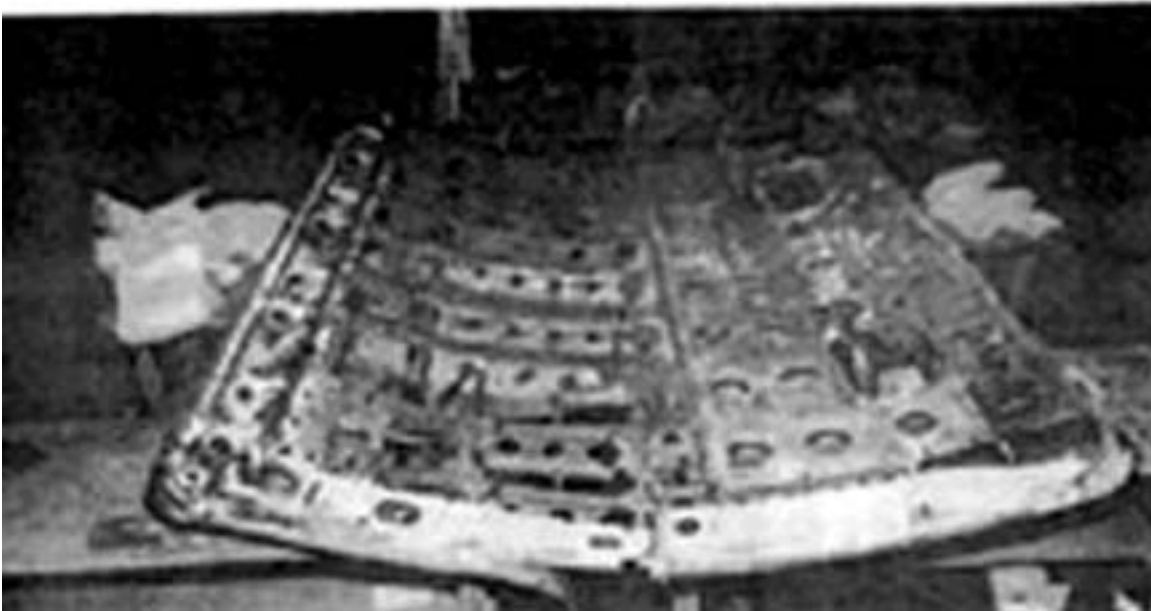
United Airlines Flight 811 forward cargo door showing missing aft pressure relief door and jammed open status of forward pressure relief door according to NTSB AAR 92/02.

'The lower two connecting rods between the lock sector torque tube and the torque tube below the pressure-relief doors were undamaged; however, the upper connecting rod had separated at the upper, tapered end. The torque tube below the pressure-relief doors were missing, and the pressure-relief door connecting rods had separated at the lower, tapered end. The remaining portion of each rod was undamaged, but the forward pressure-relief door was jammed open into the cutout.'

'The examination of the recovered forward cargo door did not provide confirmation that the pressure relief door shrouds were actually installed on the forward door, although UAL records showed that they had been installed on both cargo doors of N4713U, in accordance with SB-747-52-2097. However, the shrouds were found not to be installed on the aft door, contrary to UAL records, and therefore may not have been installed on the forward door. Without the shrouds, the pressure relief doors could have rotated shut during the pressurization cycle. Because the closure of the pressure relief doors would back-drive the lock sectors, this scenario would presume previous damage to the sectors, which would permit the sectors to move over the unlatched cams.'

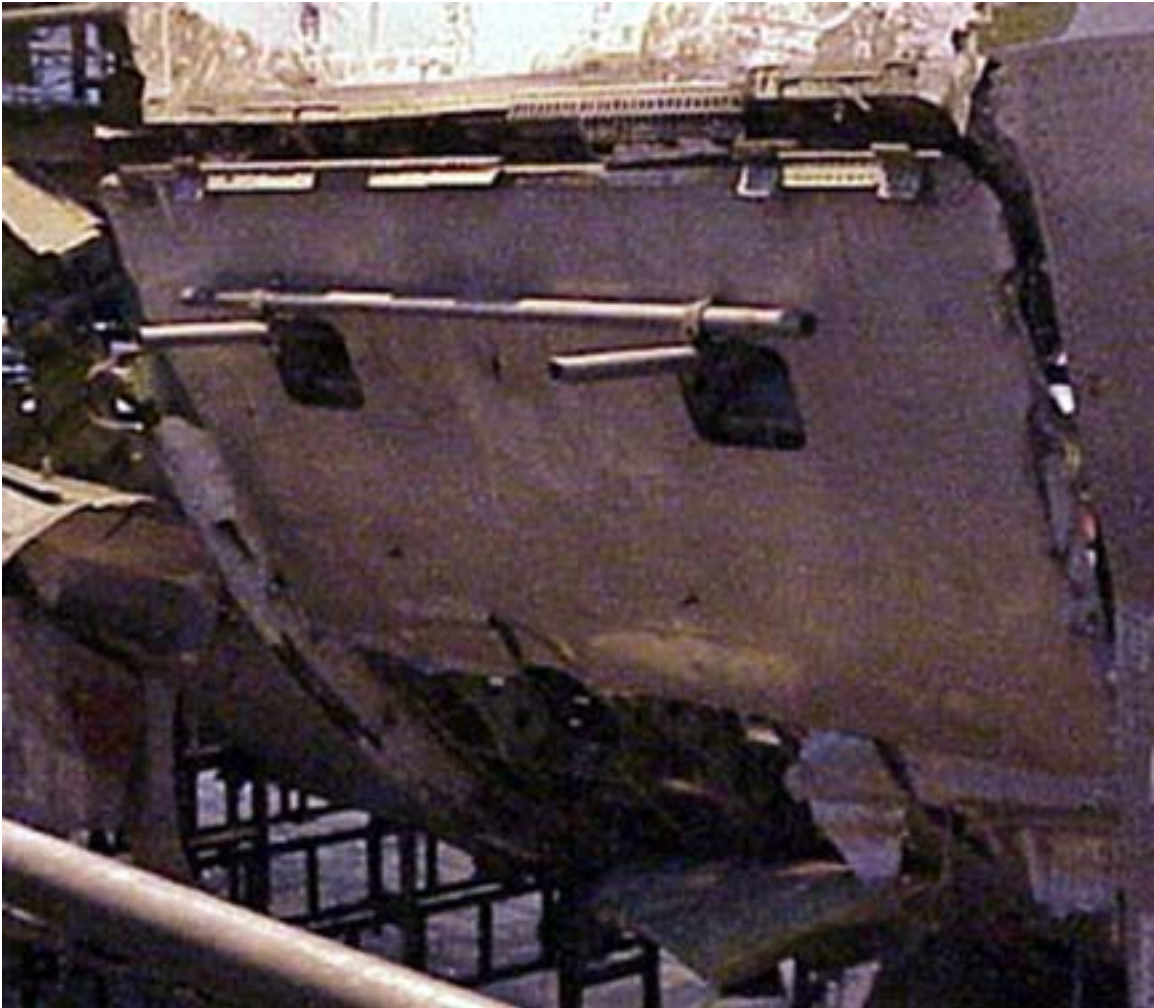
Pan Am Flight 103 Forward cargo door showing missing aft and forward pressure relief doors.

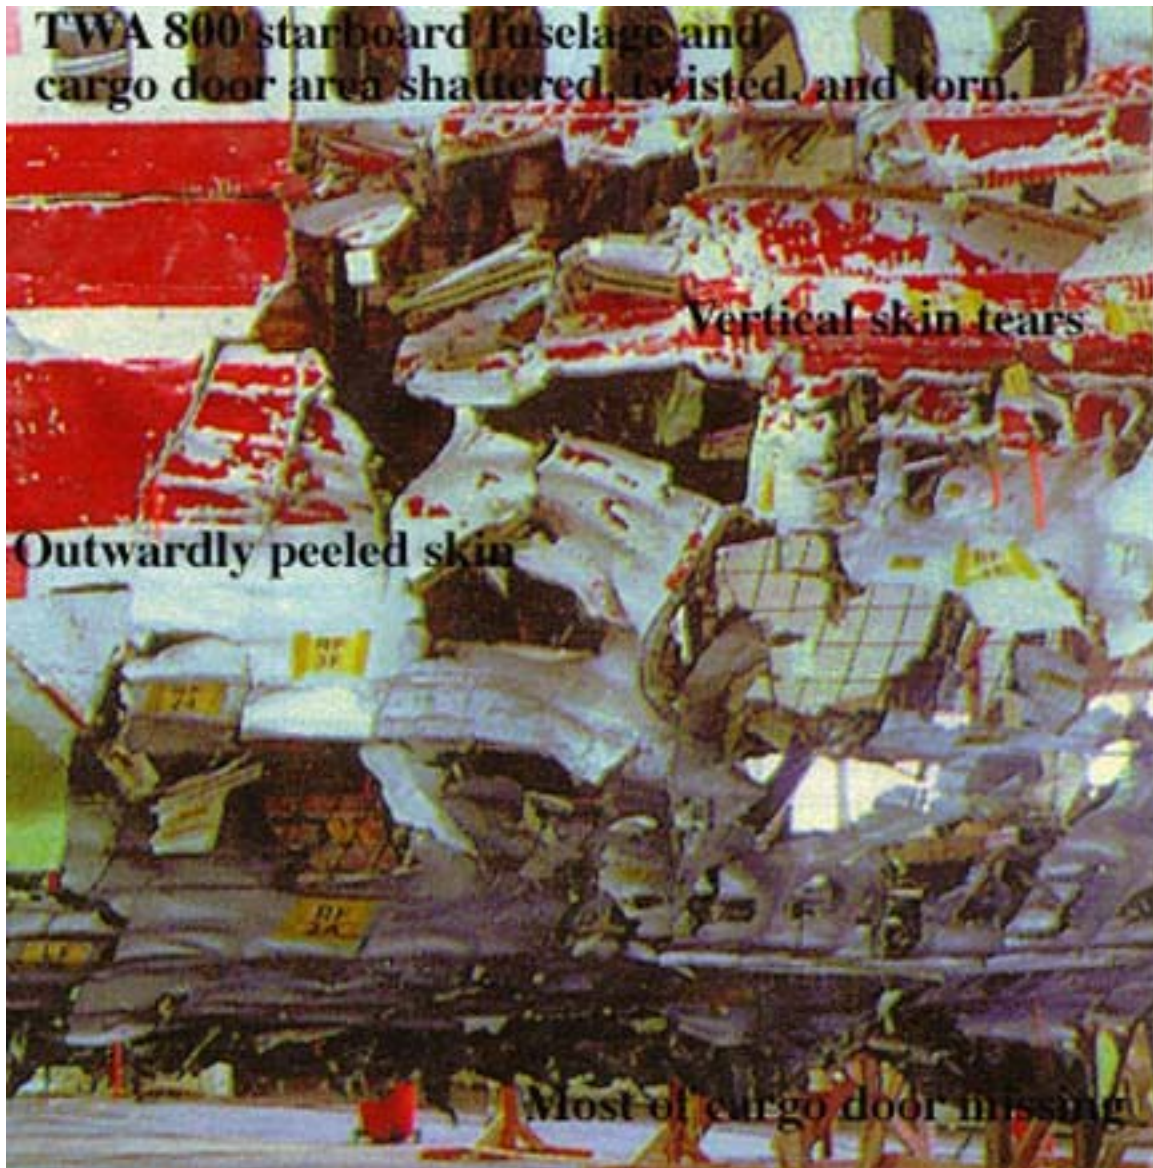
Trans World Airlines Flight 800 Forward cargo door showing missing aft pressure relief door.

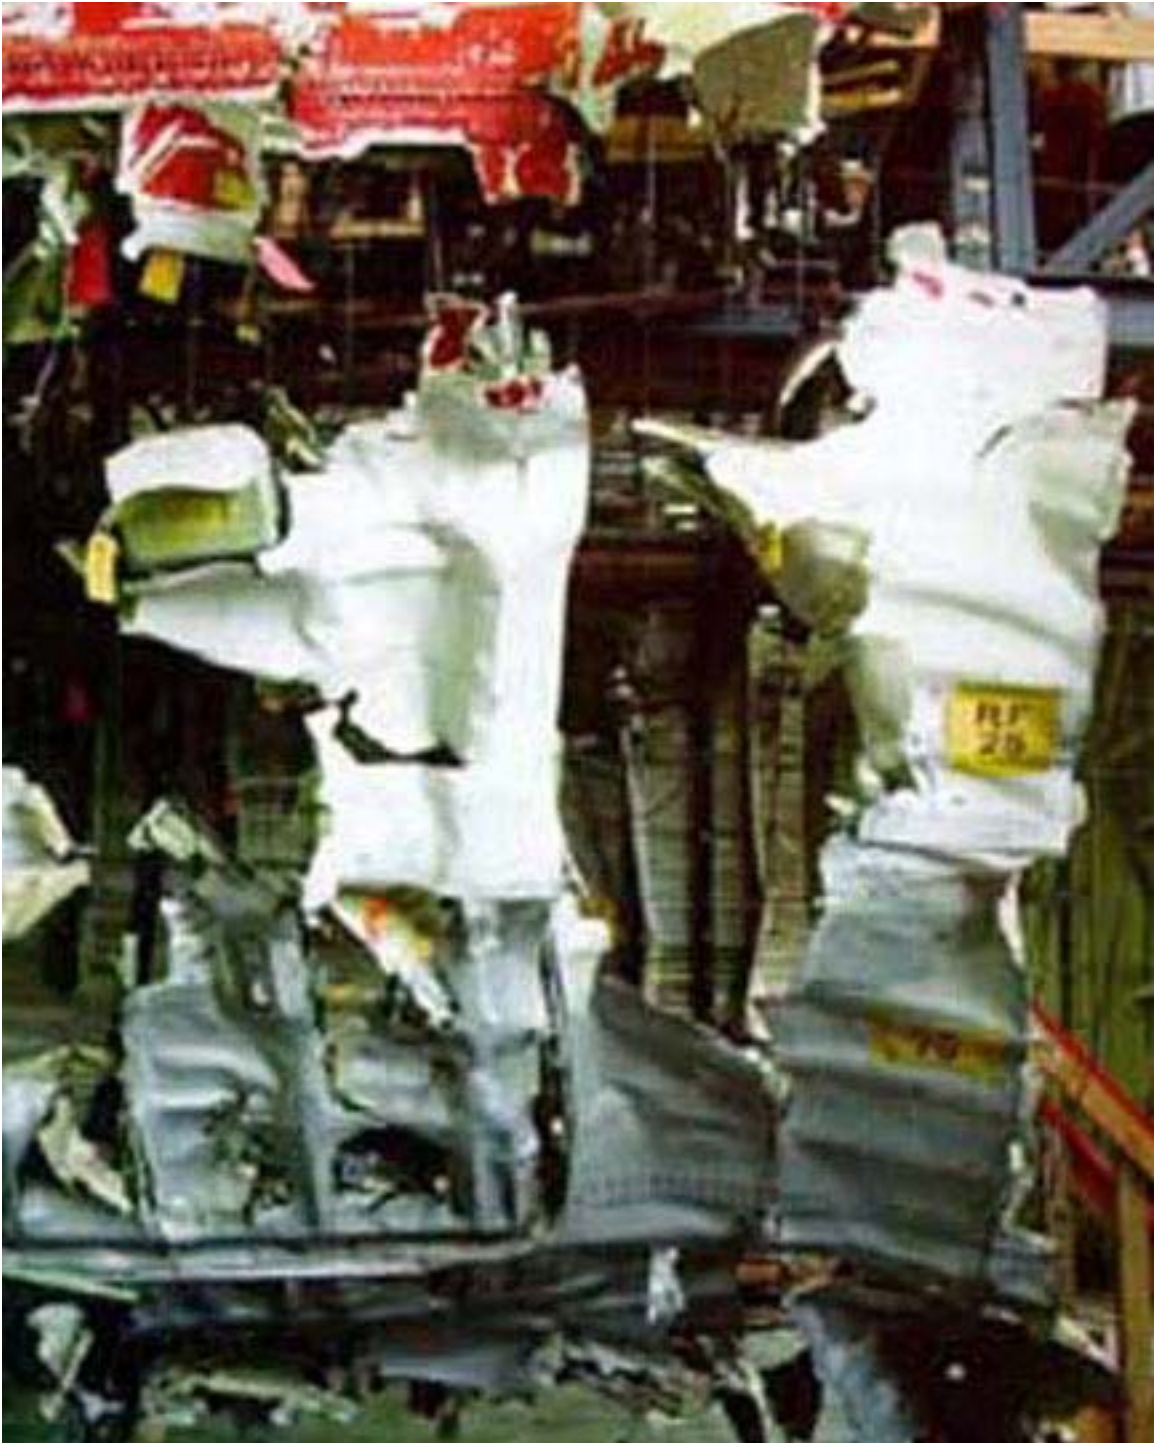
Trans World Airlines Flight 800 Forward cargo door showing separated and replaced forward pressure relief door.

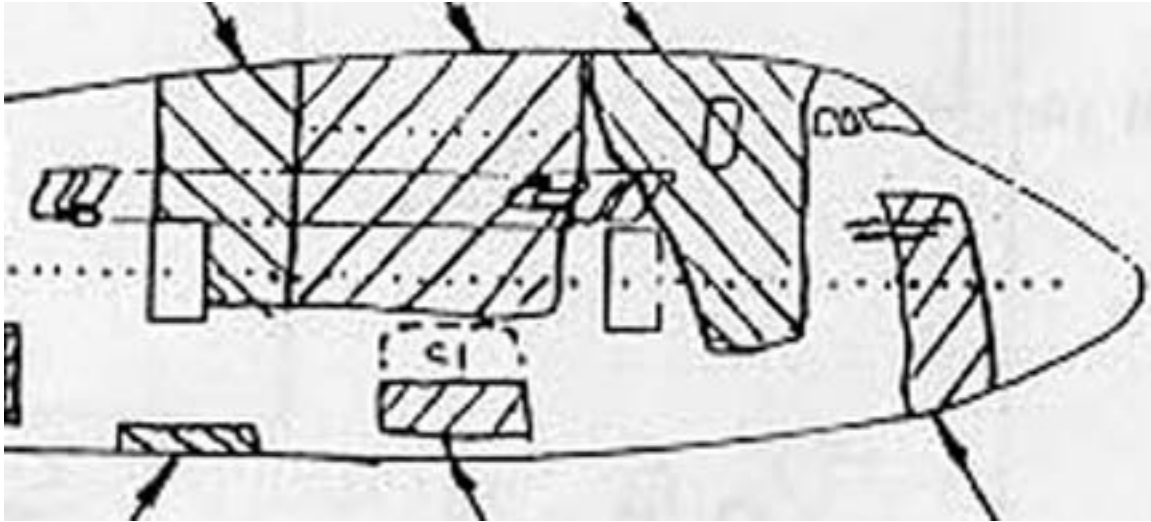
Air India Flight 182 Forward cargo door showing missing top half of door including the aft and forward pressure relief doors.

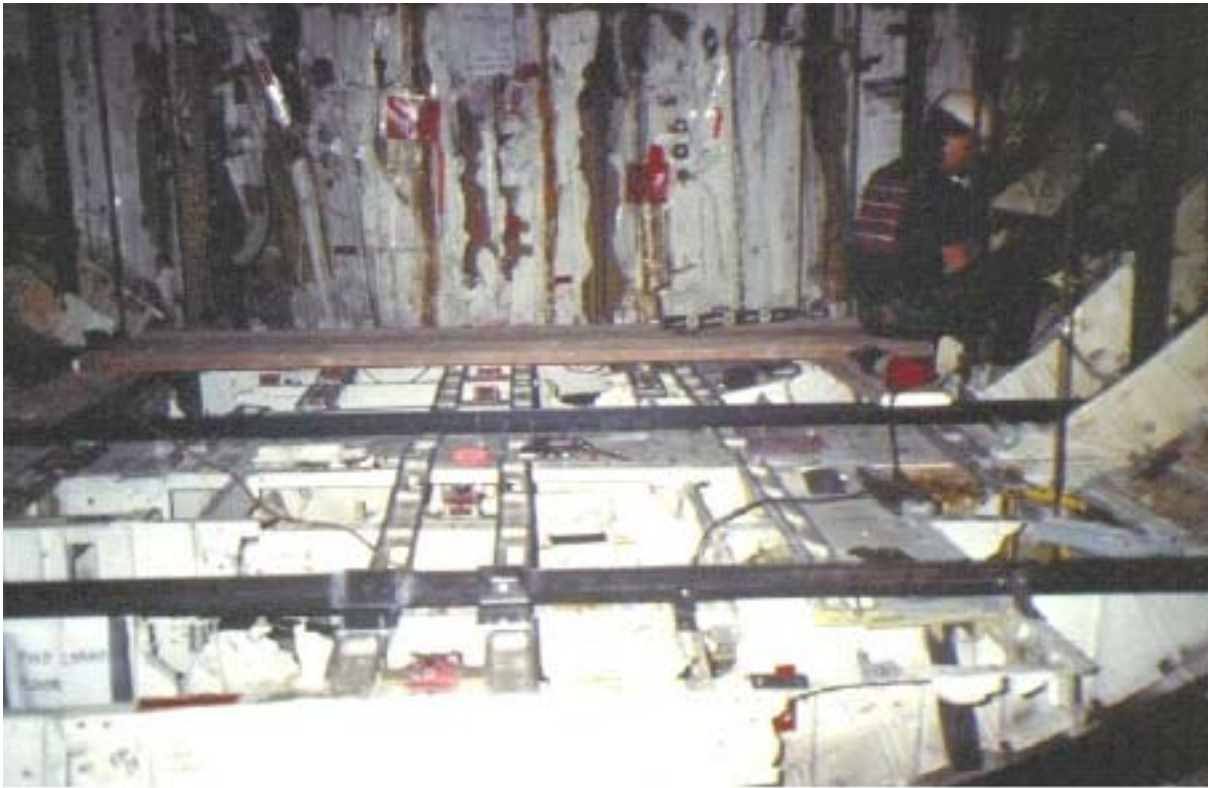
The front cargo bay area in the red zone

Red zone is area where pieces departed Trans World Airlines Flight 800 first.

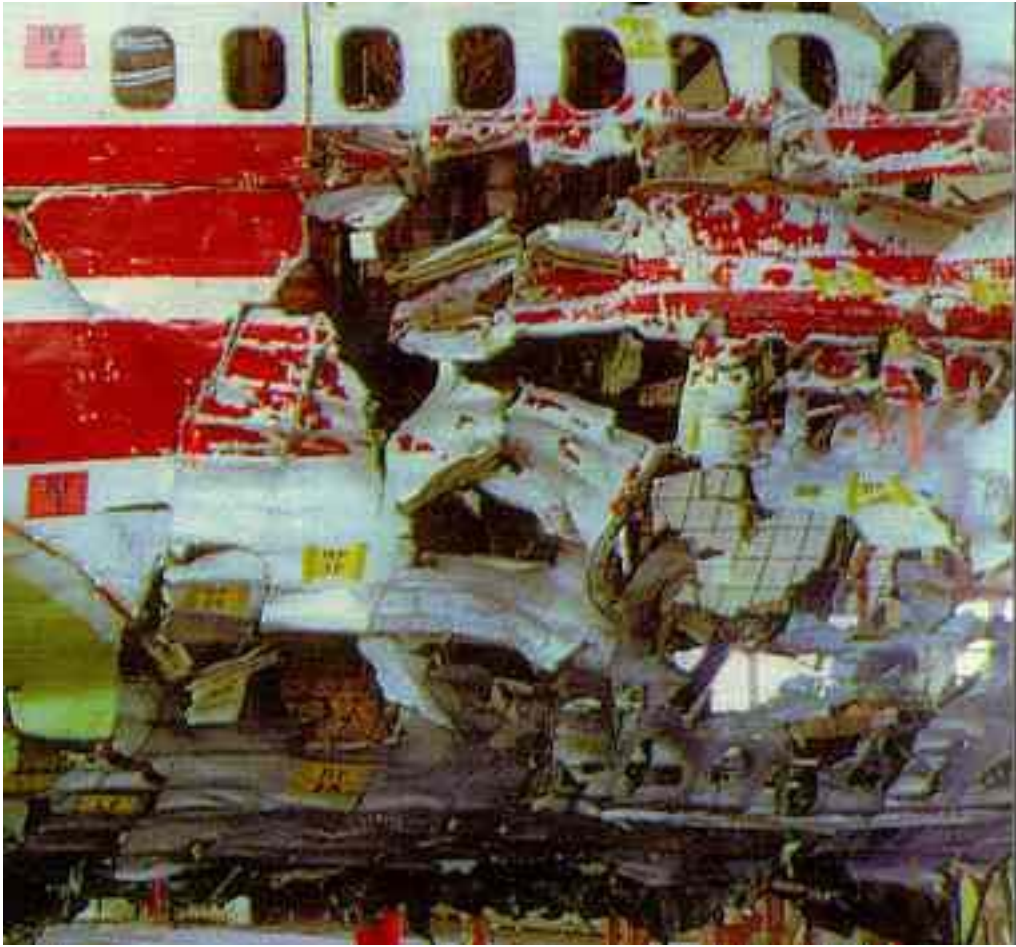
Right side of aircraft, nose to right, forward cargo door area revealing red paint smears found only in this area of Trans World Airlines Flight 800.

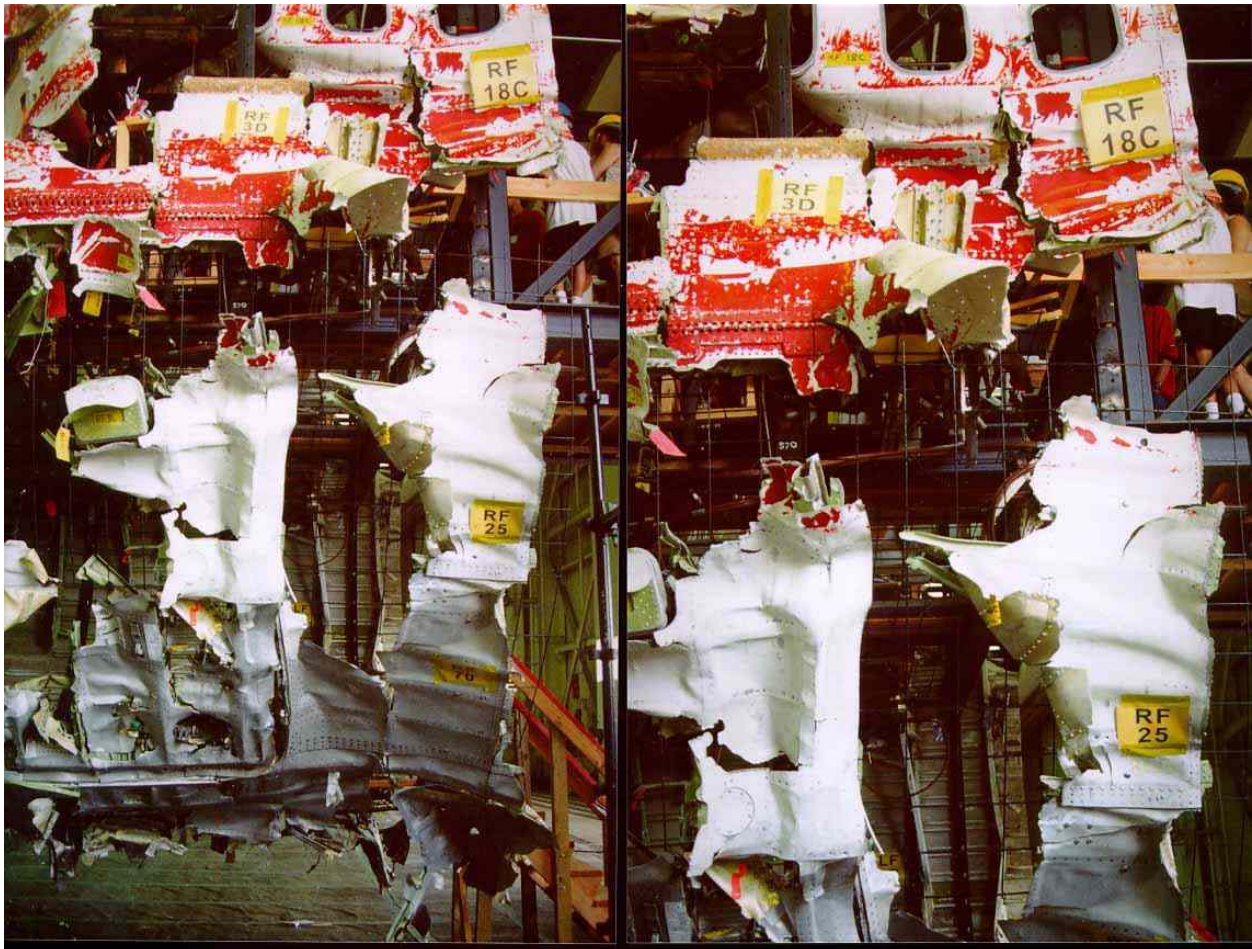
Two pictures of forward cargo door forward midspan latch area right side of aircraft, nose to right revealing outward peeled in petal shape and strange red paint smears.

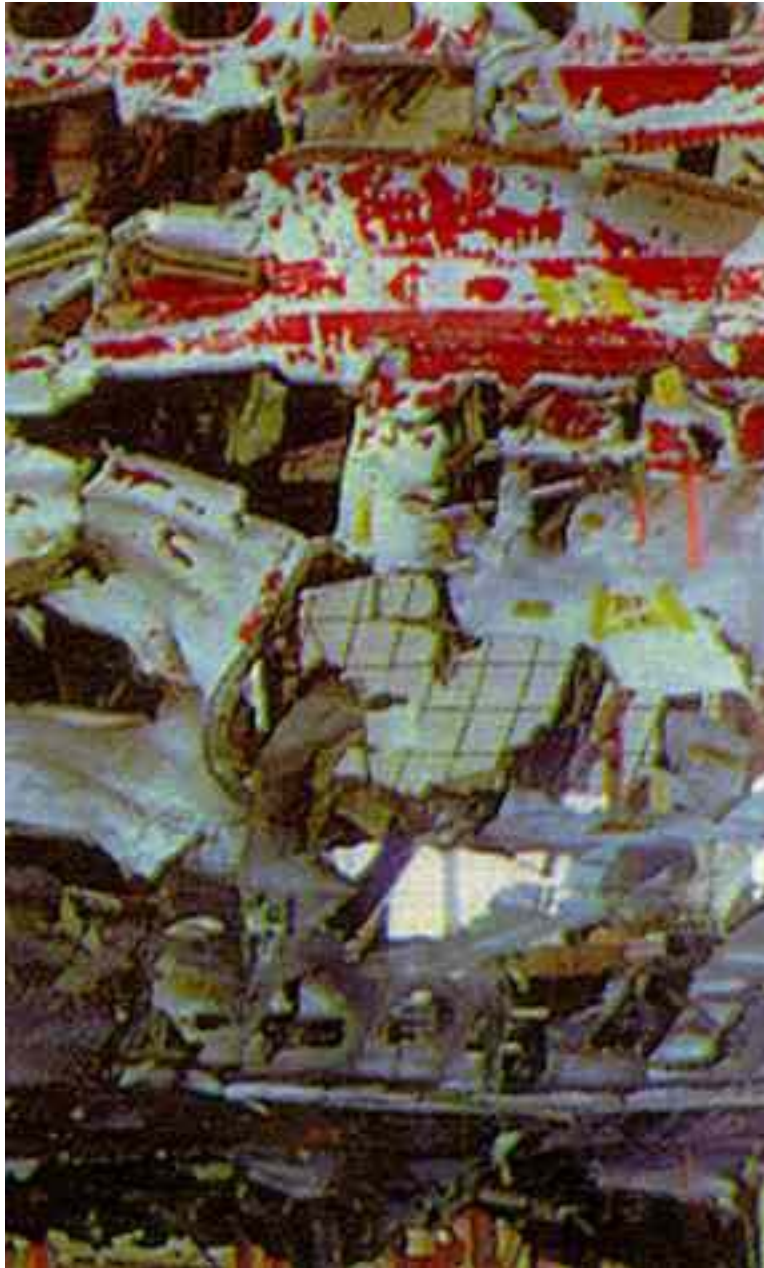
Right side of plane, aft midspan latch of forward cargo door area revealing outward, petal shaped rupture at aft midspan latch and red paint smears.
