**AIRCRAFT
ACCIDENT
REPORT
Trans World Airlines Flight 800
Part III
Door Story**

**Report on the accident to
Trans World Airlines Flight 800
Boeing 747-131, N93119
Near East Moriches, New York
July 17, 1996
by John Barry Smith,
Independent Aircraft Accident Investigator**

Part III: Door Story

Forward Cargo Door Areas Compared for United Airlines Flight 811, Pan Am Flight 103, Air India Flight 182, and Trans World Airlines Flight 800.

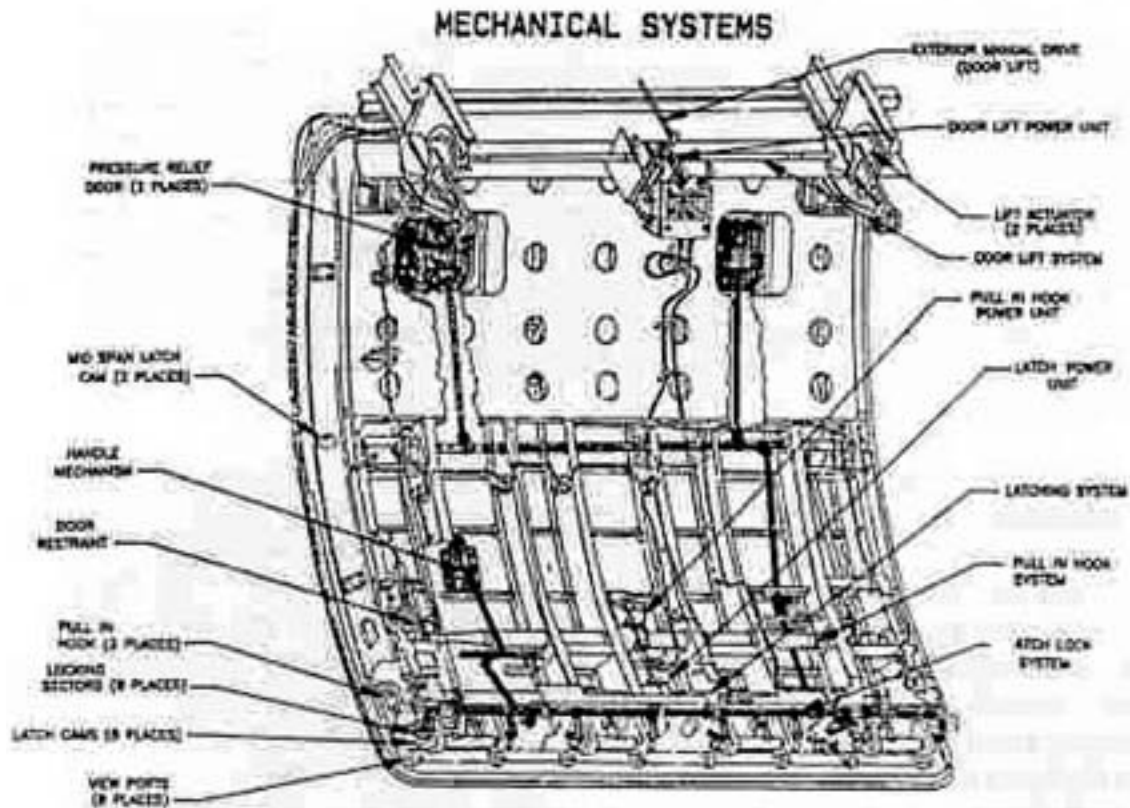
Drawing of Boeing 747 cargo door from NTSB AAR 92/02.

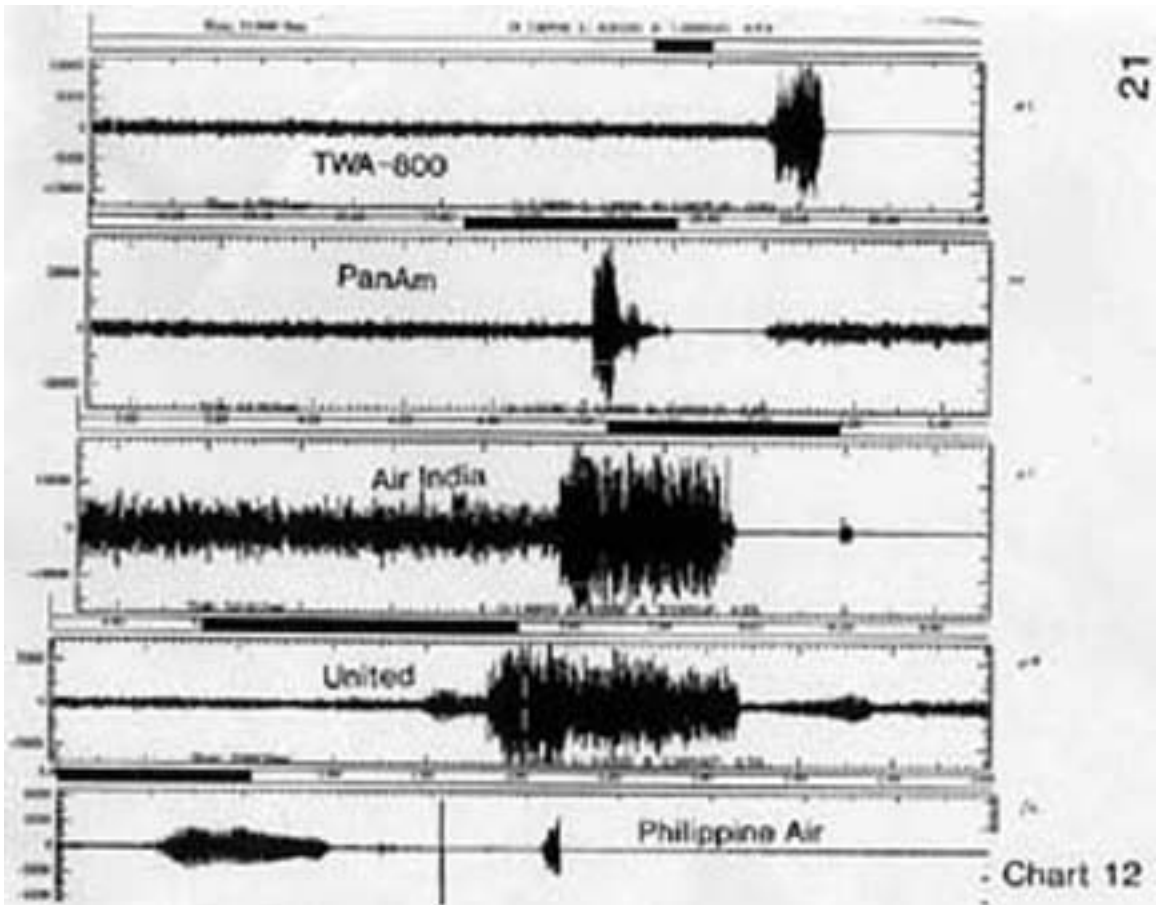
Chart 12 from Public Docket for Trans World Airlines Flight 800 comparing the sudden loud sounds from the inflight CVRs of Trans World Airlines Flight 800, Pan Am Flight 103, Air India Flight 182, United Airlines Flight 811 and a Boeing 737 on the ground.

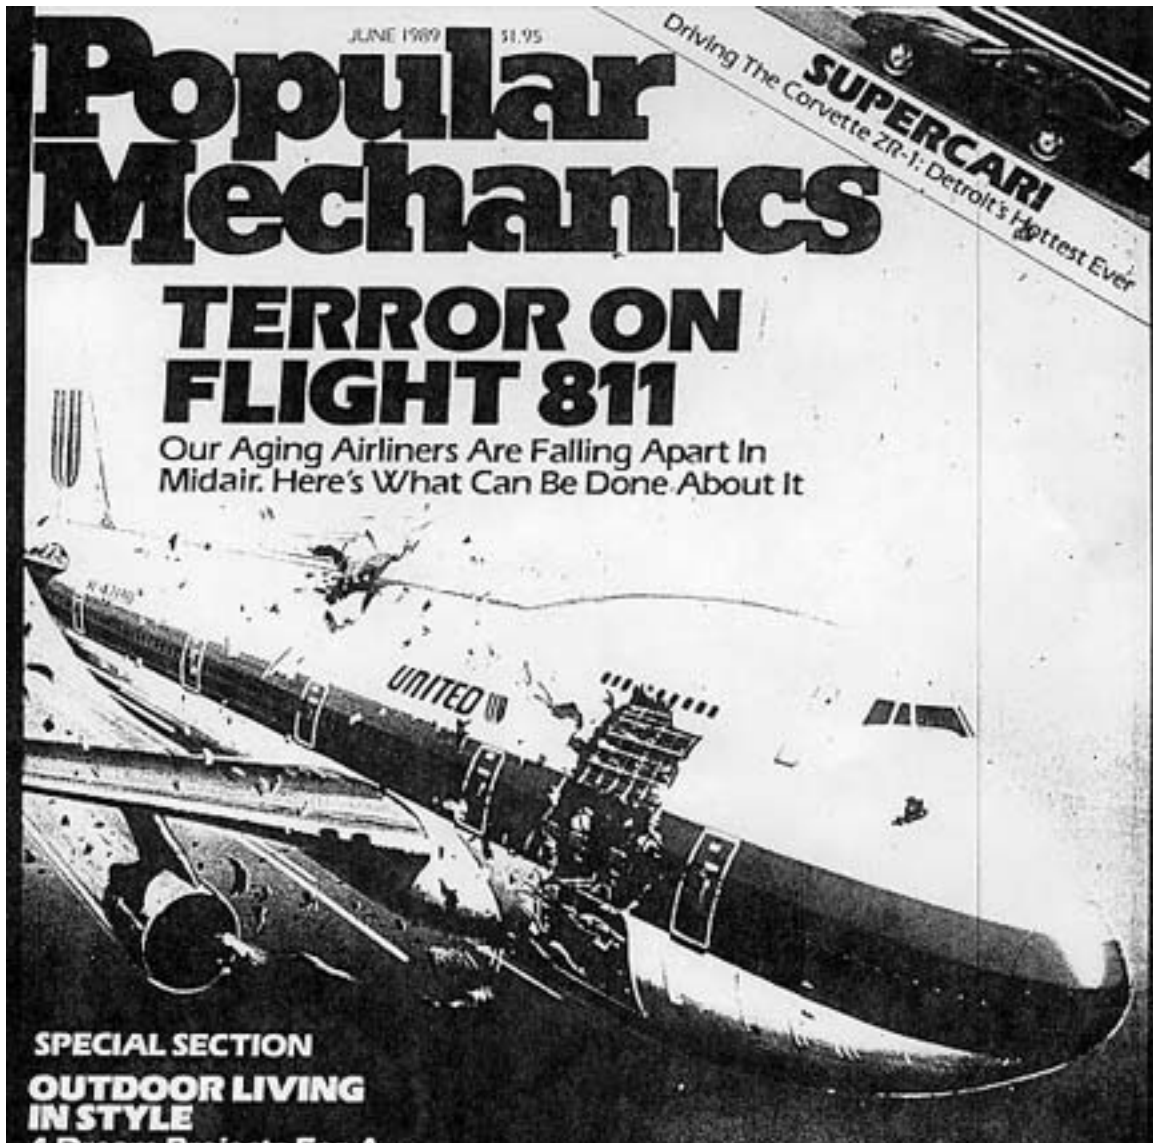
Melodramatic artist's impression on cover of June 1989 Popular Mechanics showing United Airlines Flight 811 as it descends to land after inadvertent opening of forward cargo door in flight.

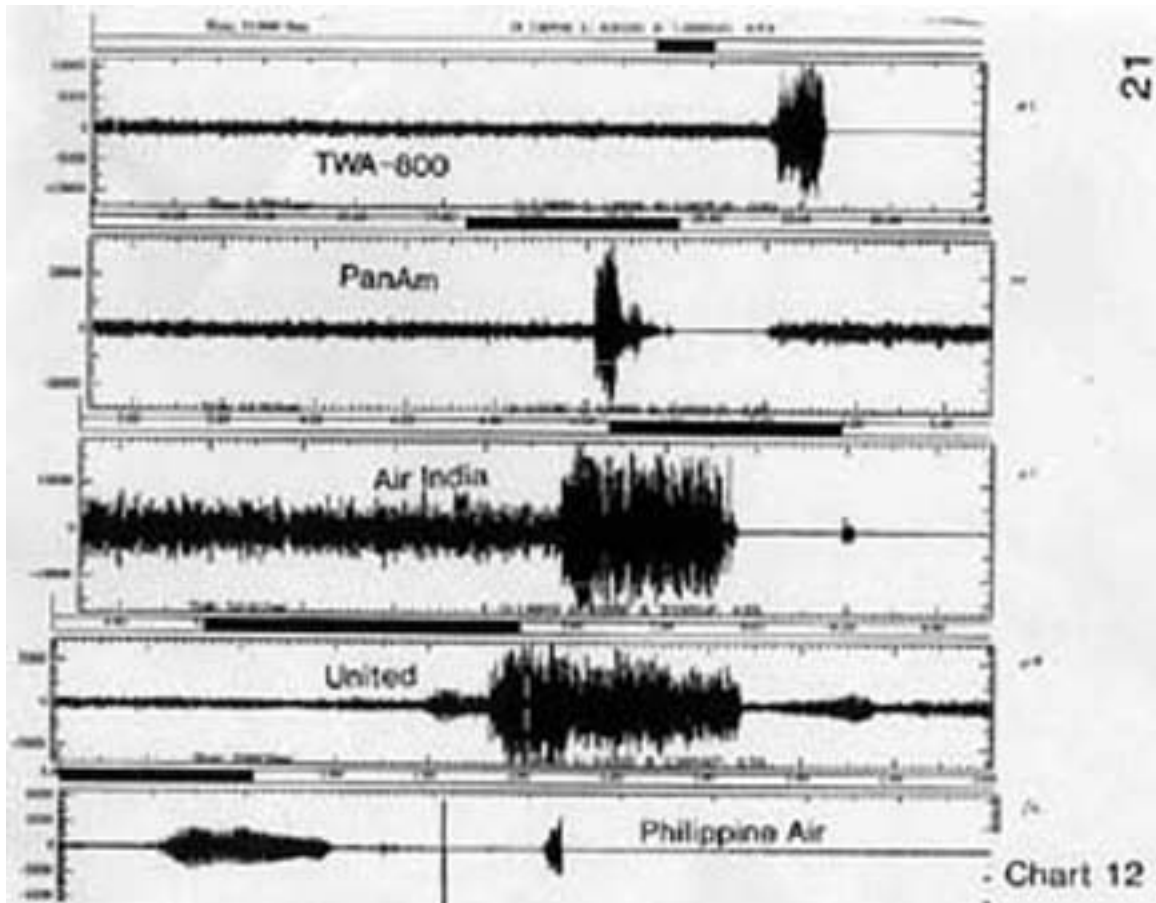
Air India Flight 182:

"From the CVR and DFDR, AI 182 was proceeding normally en route from Montreal to London at an altitude of 31,000 feet and an indicated airspeed of 296 knots when the cockpit area microphone detected a sudden loud sound. The sound continued for about 0.6 seconds, and then almost immediately, the line from the cockpit area microphone to the cockpit voice recorder at the rear of the pressure cabin was most probably broken. This was followed by a loss of electrical power to

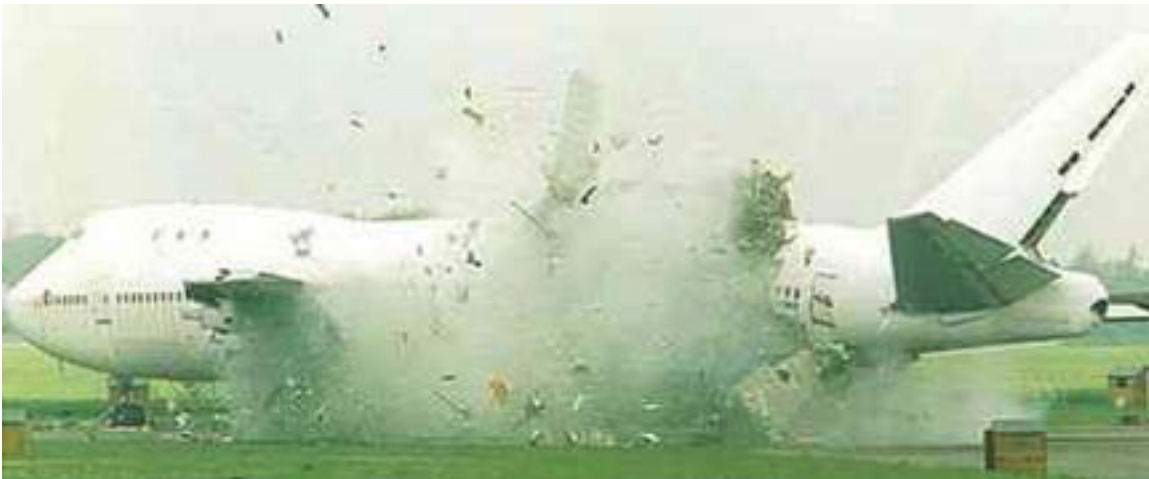
Staged bombing of a Boeing 747 at Bruntingthorpe UK showing the massive damage which occurs when a real bomb goes on in a Boeing 747.

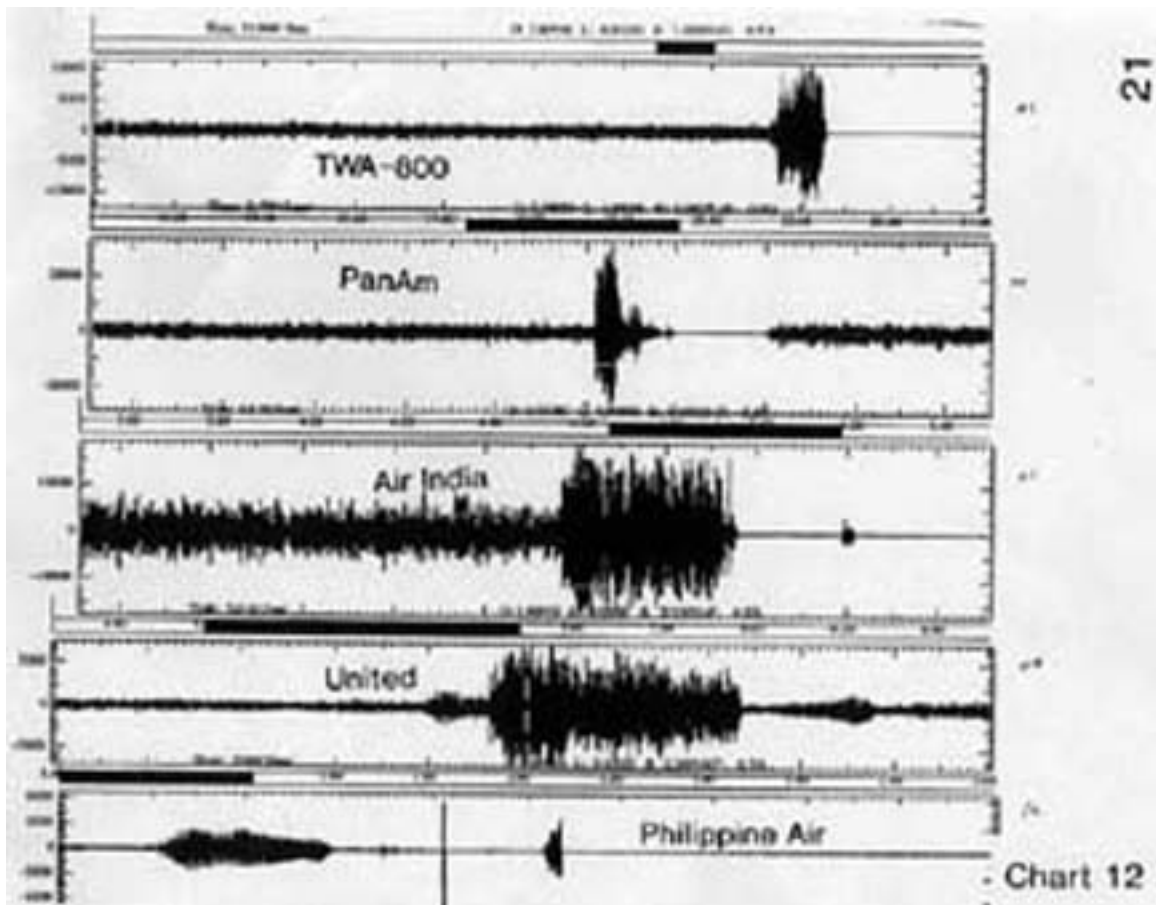
Pan Am Flight 103:

"The CVR tape was listened to for its full duration and there was no indication of anything abnormal with the aircraft, or unusual crew behaviour. The tape record ended, at 19:02:50 hrs +/- second, with a sudden loud sound on the CAM channel followed almost immediately by the cessation of recording whilst the crew were copying their transatlantic clearance from Shanwick ATC." UK AAIB Report 2/90 Page 15

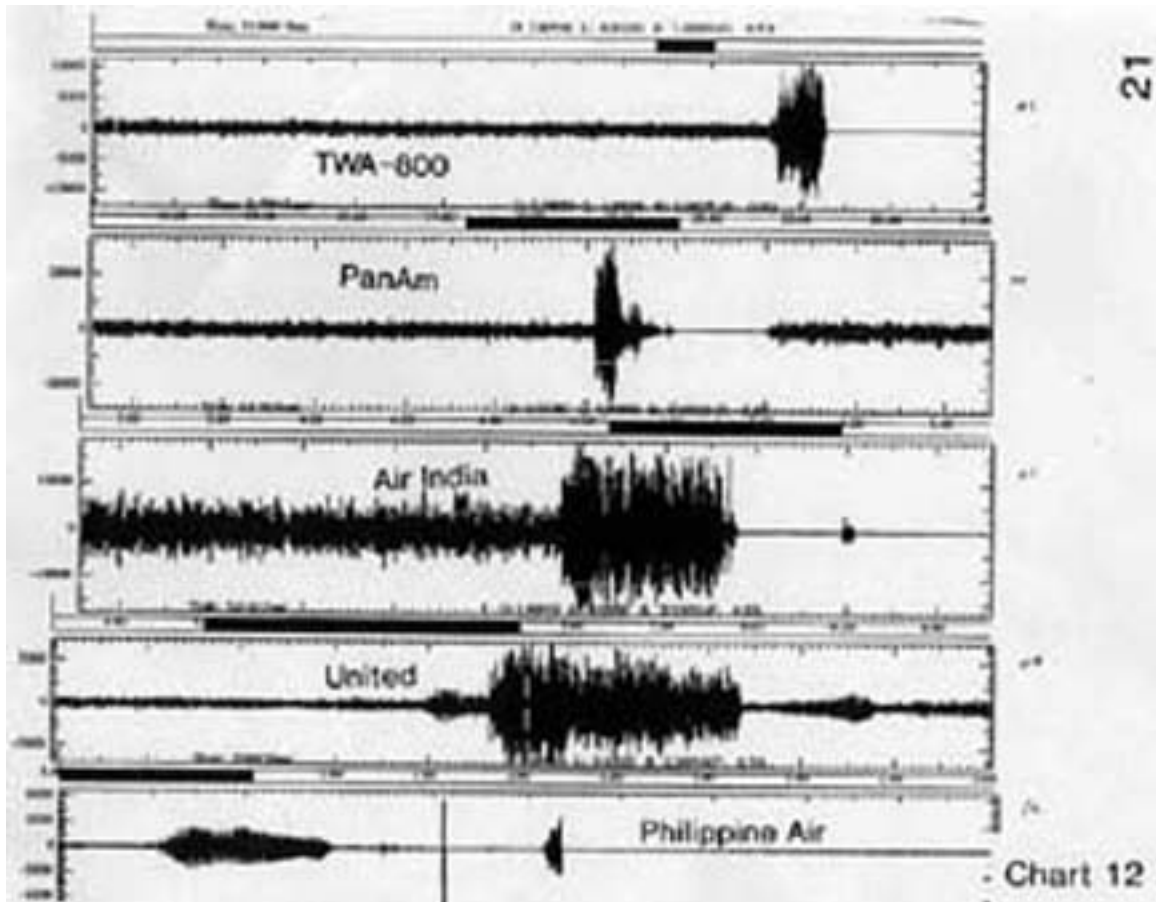
From NTSB: The CVR then recorded a very loud sound for a fraction of a second (0.117 second) on all channels immediately before the recording ended. The accident airplane's last recorded radar transponder return occurred at 2031:12, and a review of the FDR data indicated that the FDR lost power at 2031:12.

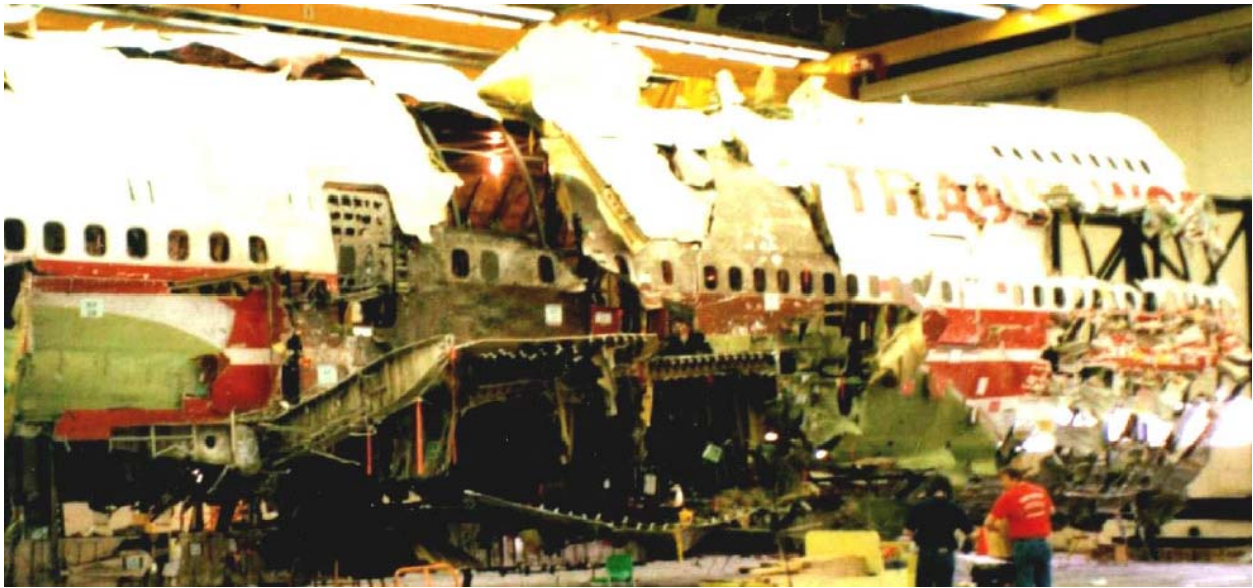
The right side of the plane

Nose to right

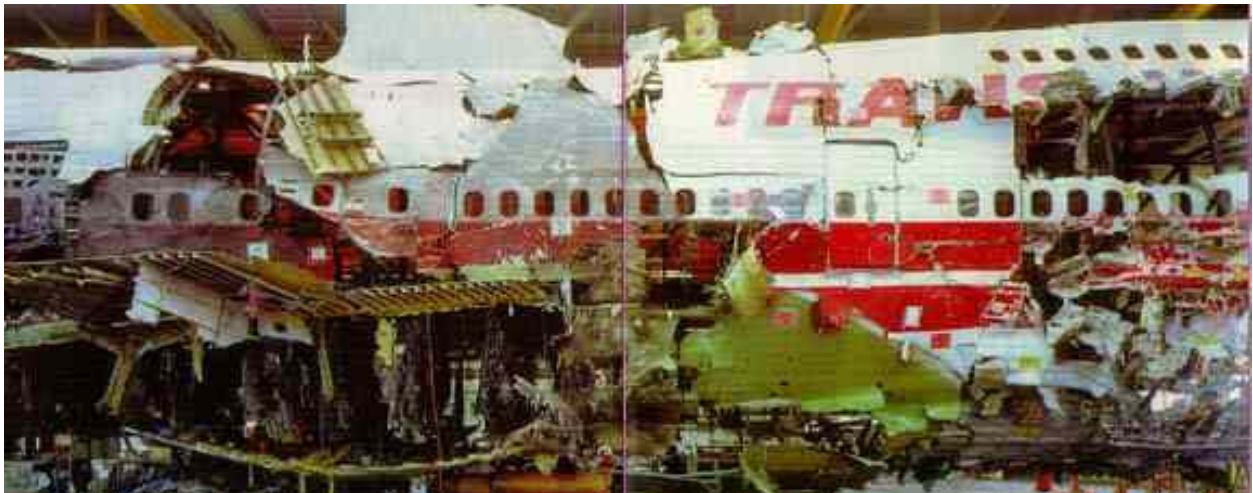
The right side of plane, nose to right.

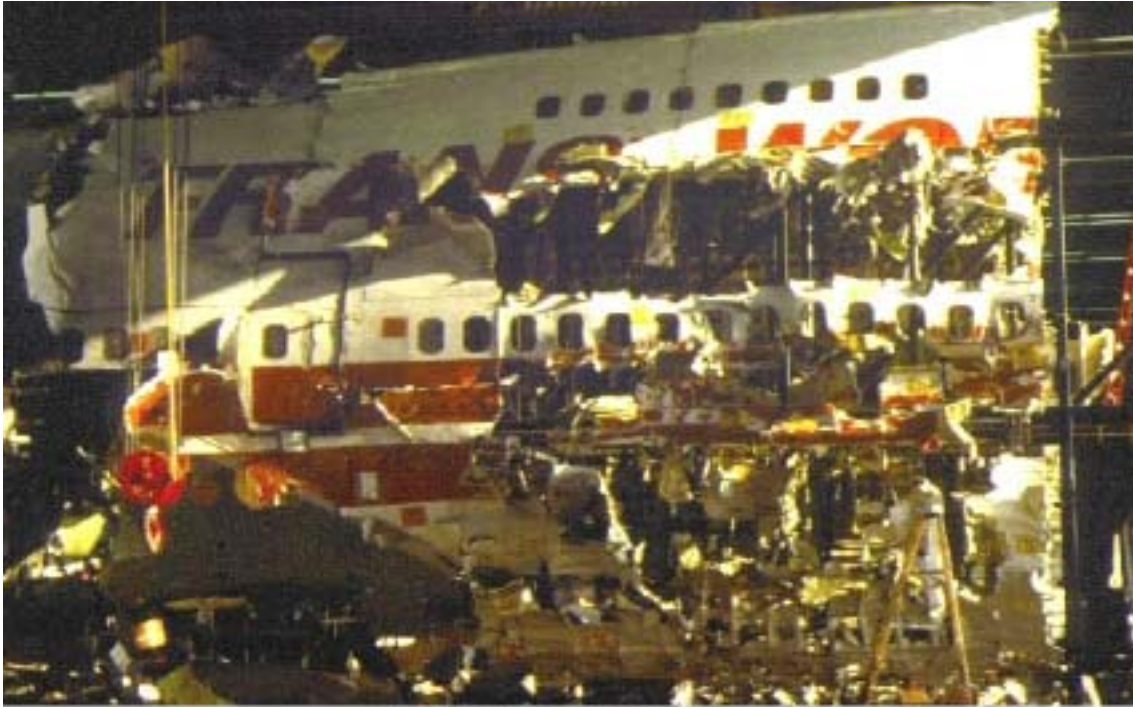
Right front of the plane

Nose to right.

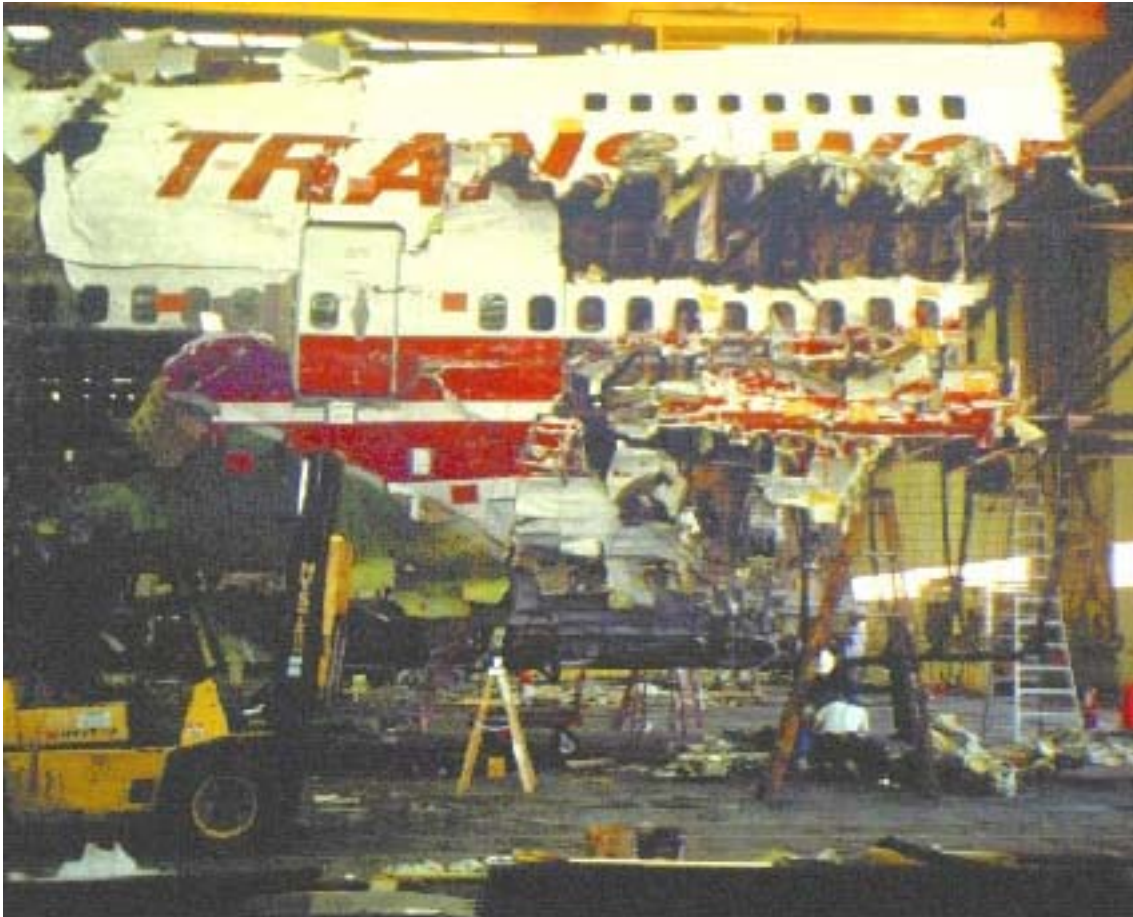
The right front of the reconstruction

Nose to right.

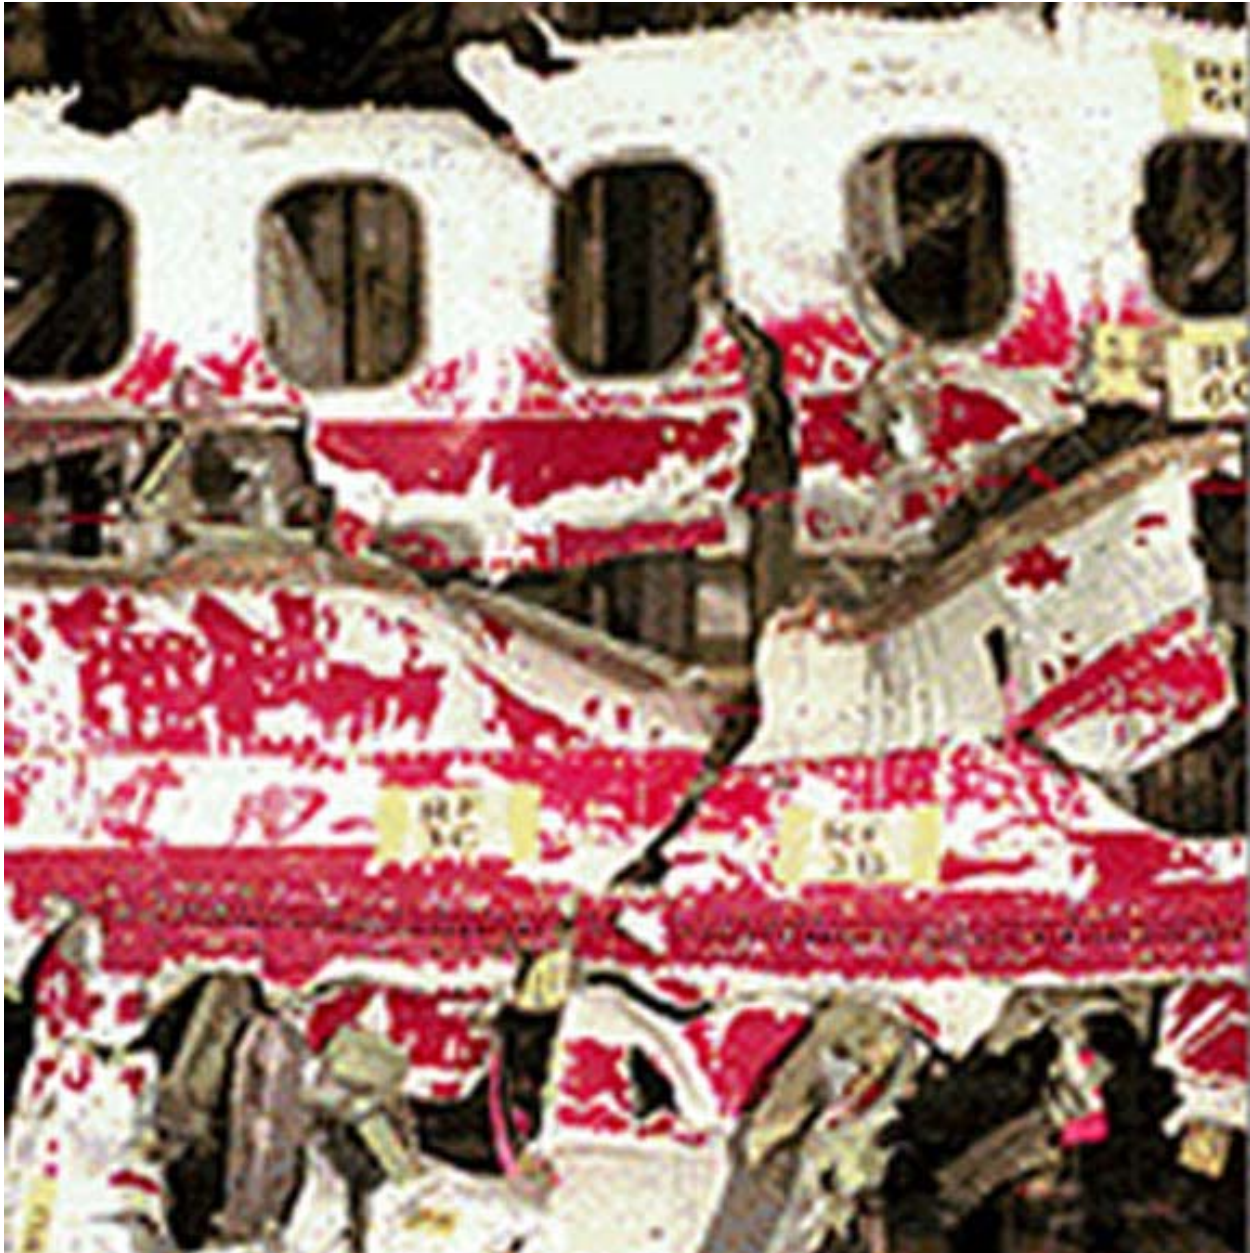
Right side above forward cargo door hinge, nose to right.
